CULTURAL LANDSCAPE INVENTORY:
SHELLROCK MOUNTAIN TO RUTHTON POINT

HISTORIC COLUMBIA RIVER HIGHWAY

Prepared For:
Oregon State Department of Transportation

January 2010

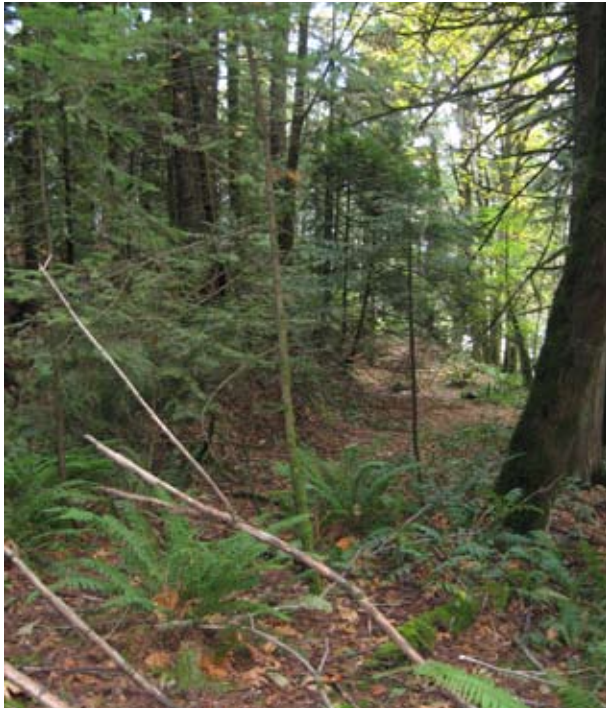
Lindsey Creek intersection, abandoned road

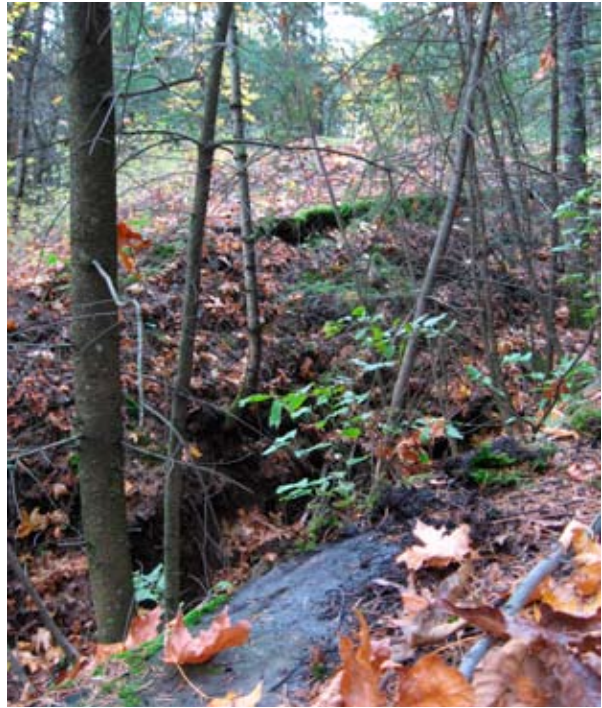
Broken Pavement, Mitchell Creek diversion, Mitchell Point 2

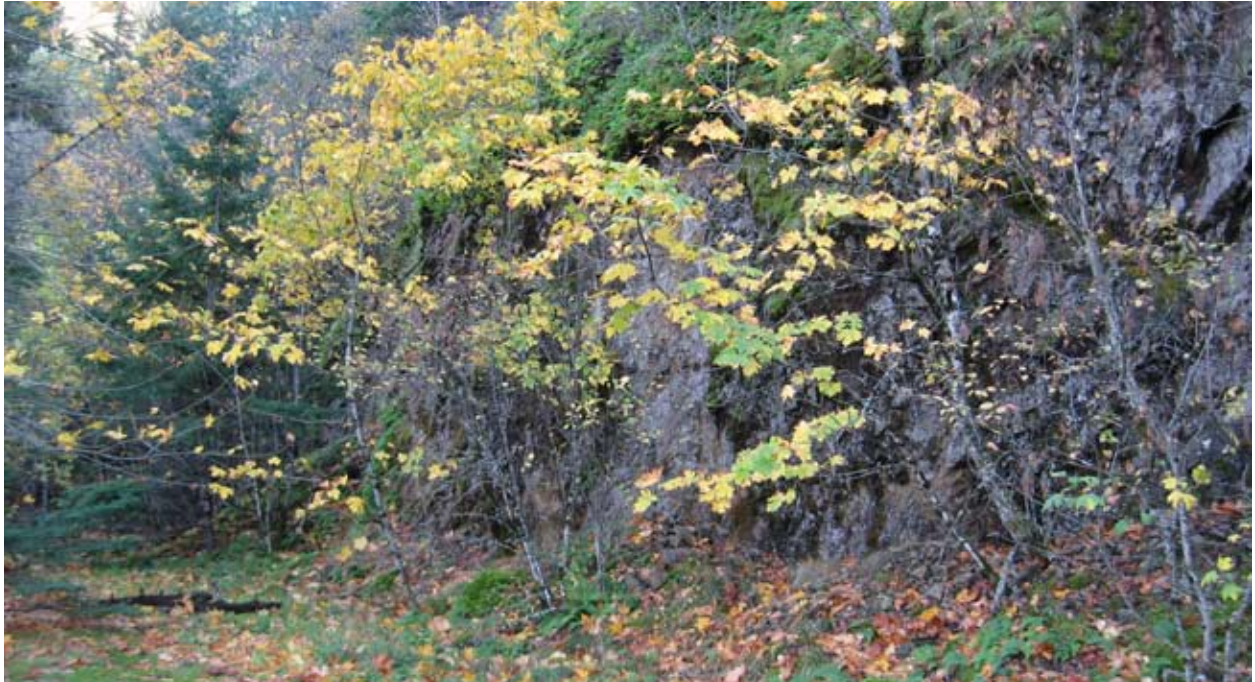
Rock Cut, Mitchell Point. The vegetation and piled debris at its base are signs of poor condition. Note the slide in the background.

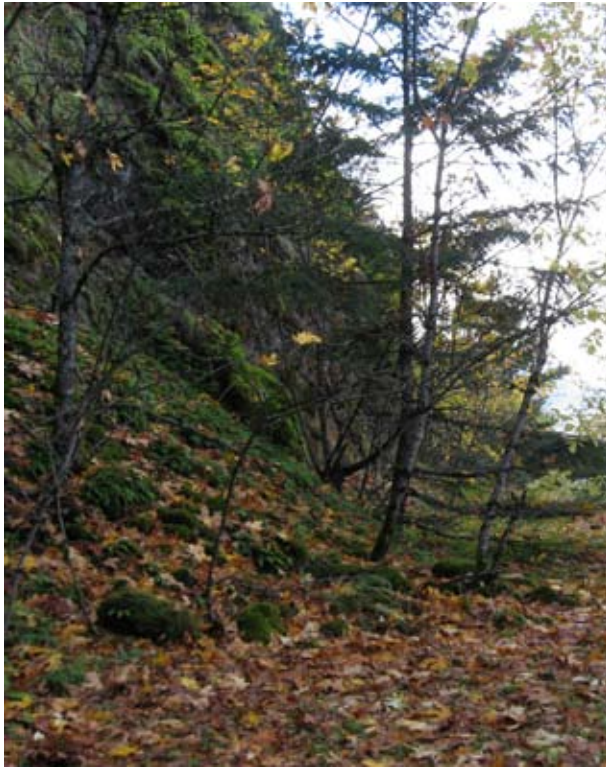
Rock cut, slide, Perham Creek

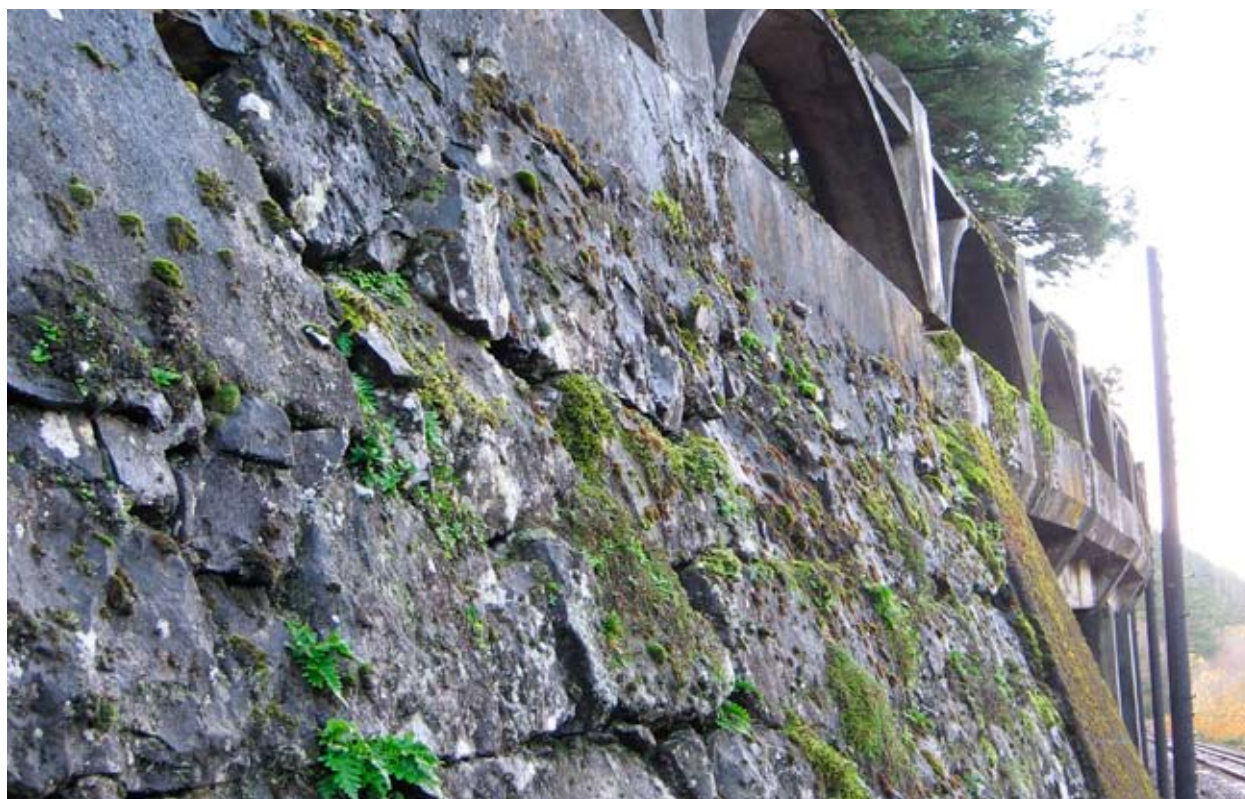
Retaining wall, viaduct and guard rail, near Multnomah Falls. The retaining wall is battered (sloped to the base), dry laid, unbossed, and laid in a random pattern. Many chink stones are missing, some can be seen.

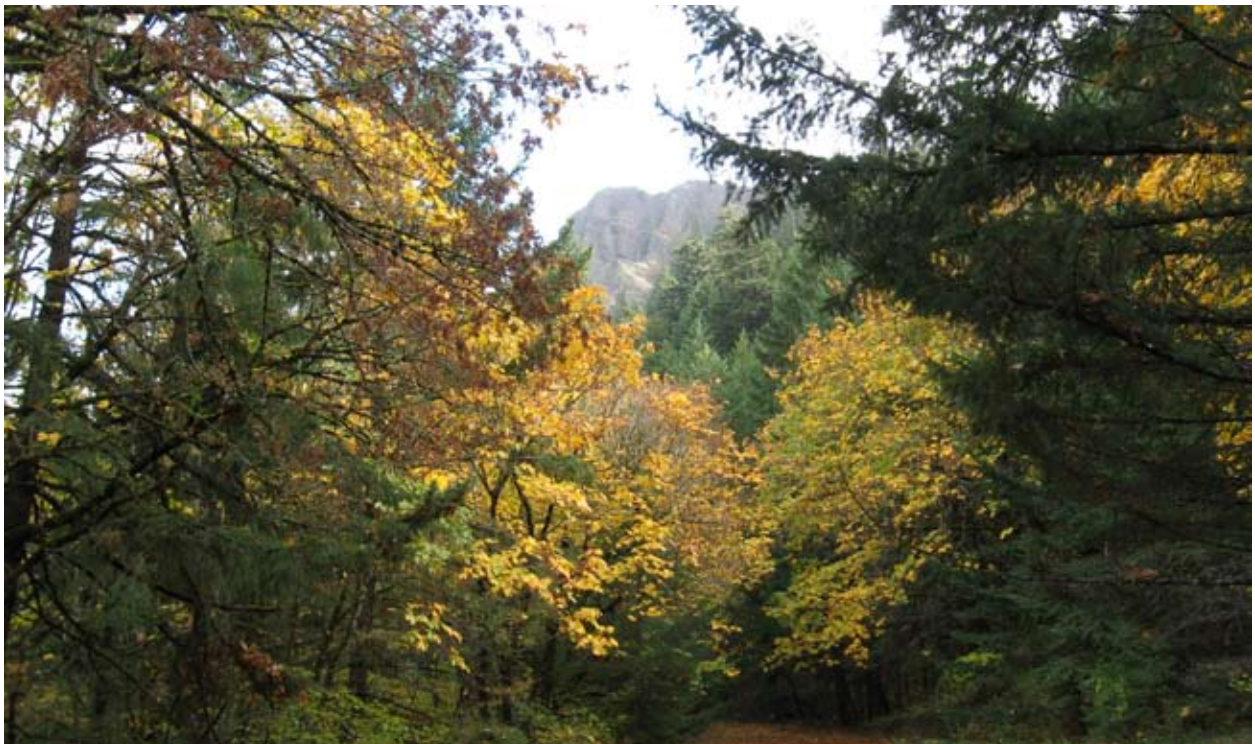
Framed, axial view of Mitchell Point , overgrown with vegetation

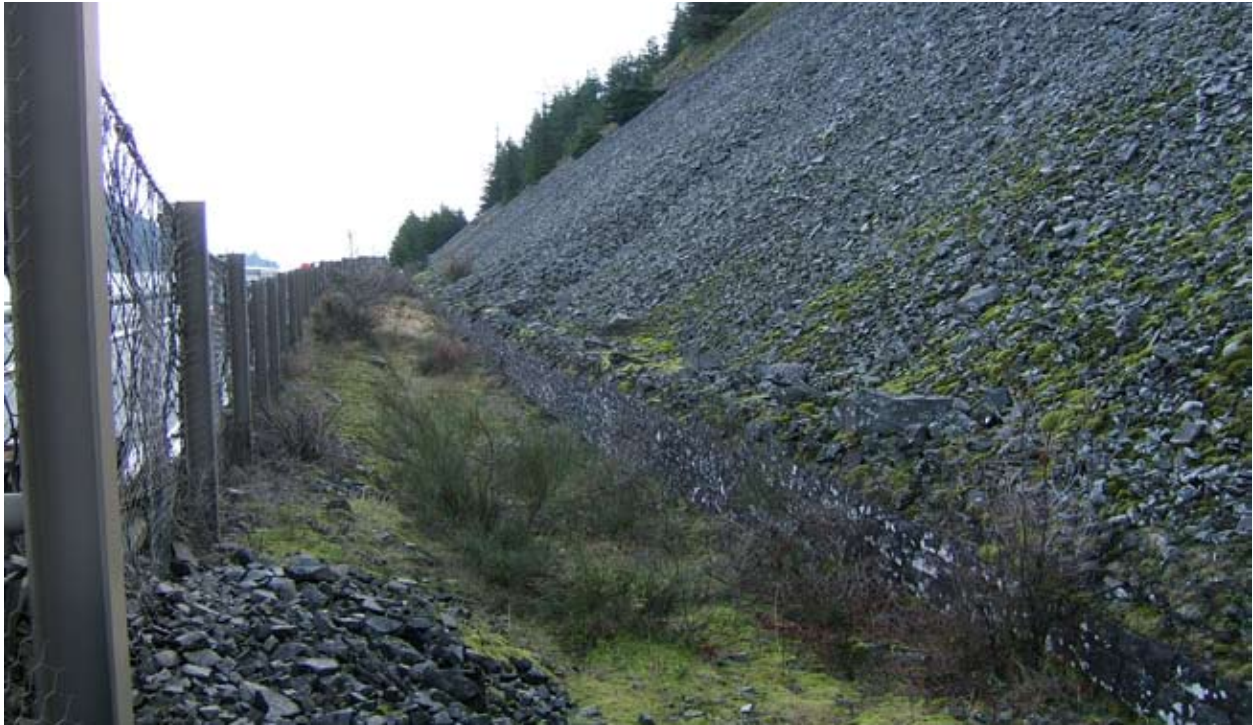
Retaining wall and rock catchment, Shellrock Mountain

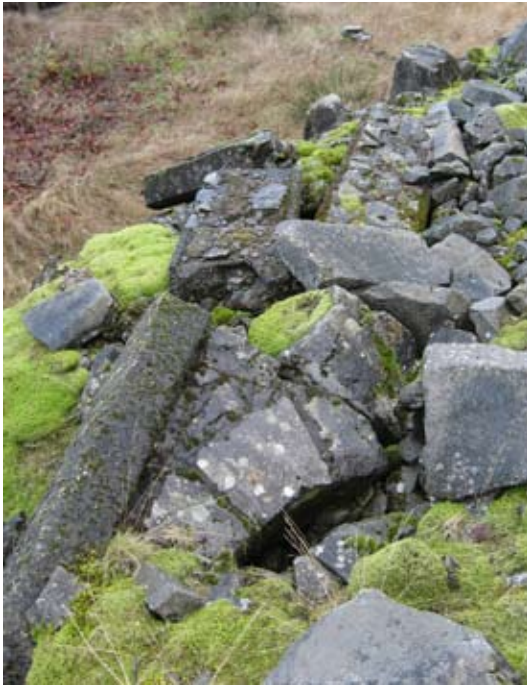
Broken parapet, Shellrock Mountain

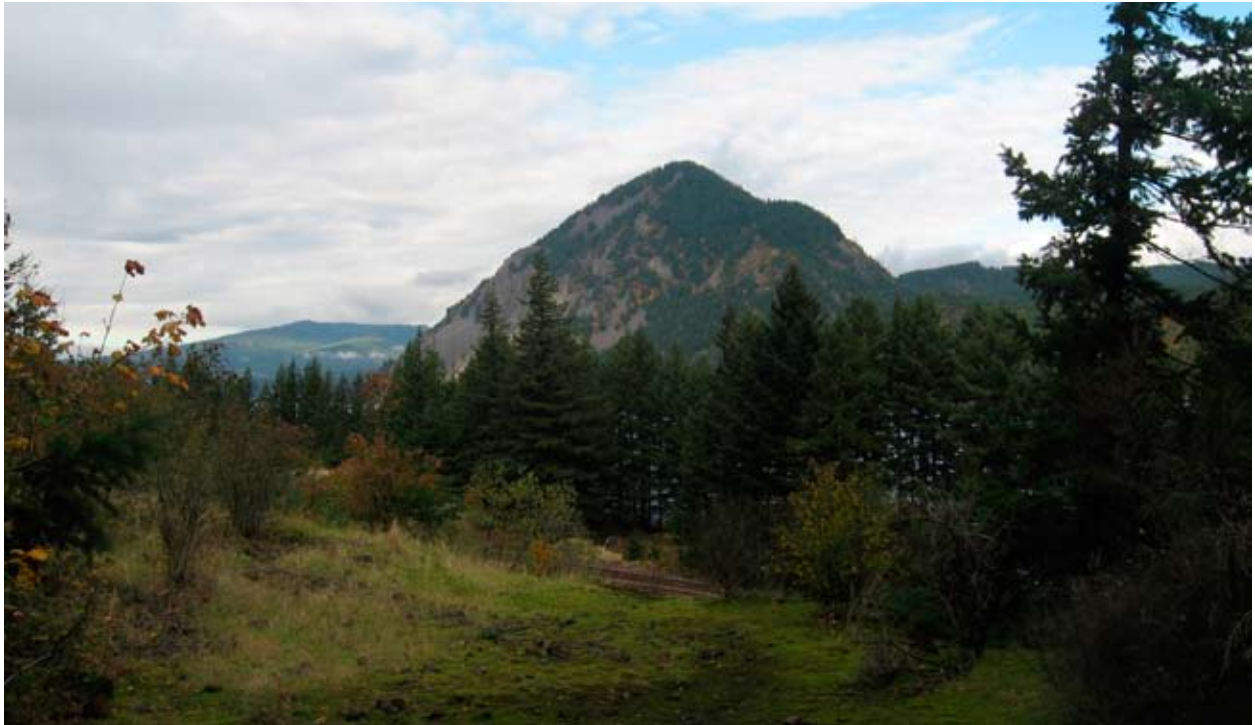
The view of Wind Mountain at the western end of the segment is in poor condition, compromised by vegetation, the concrete barrier at the end of the segment, and the Interstate below. The inventory also identified a vista to the south, up a steep draw framed by interesting rock formations. This vista is in poor condition as well, as it is overgrown with small trees.

View of Wind Mountain from east end of Lindsey Creek Segment

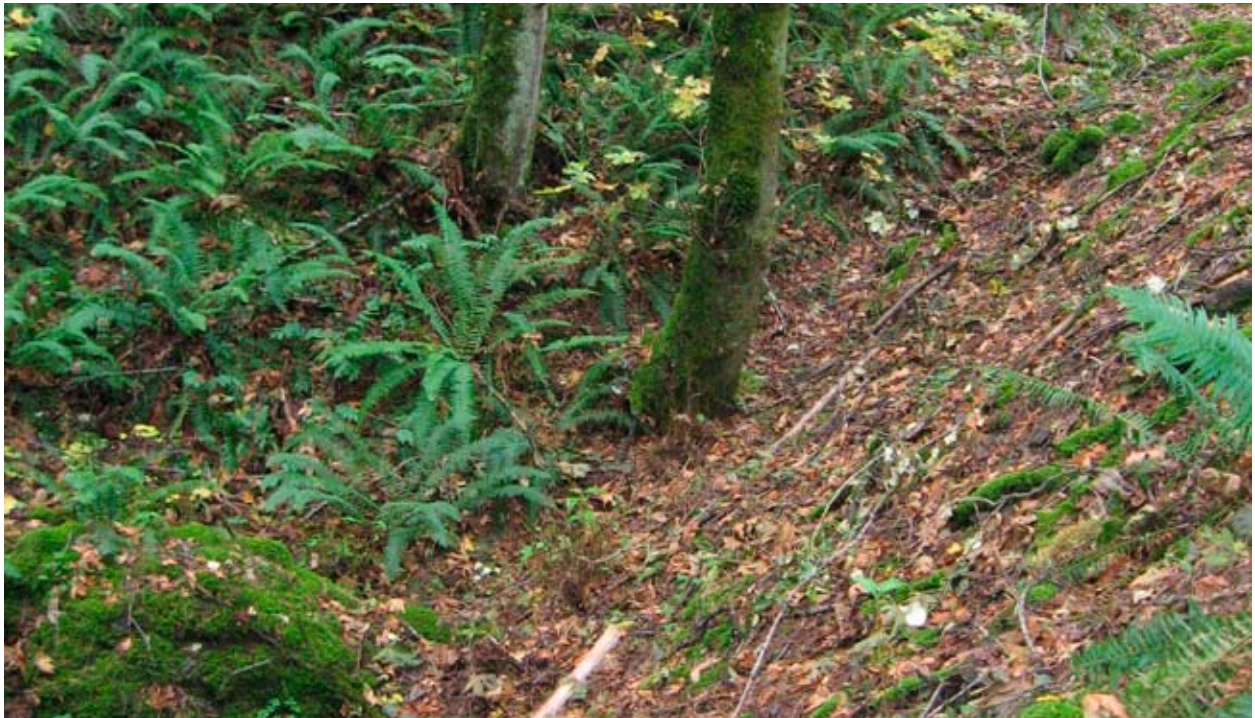
Fill-through, blocked drainage, Lindsey Creek Segment

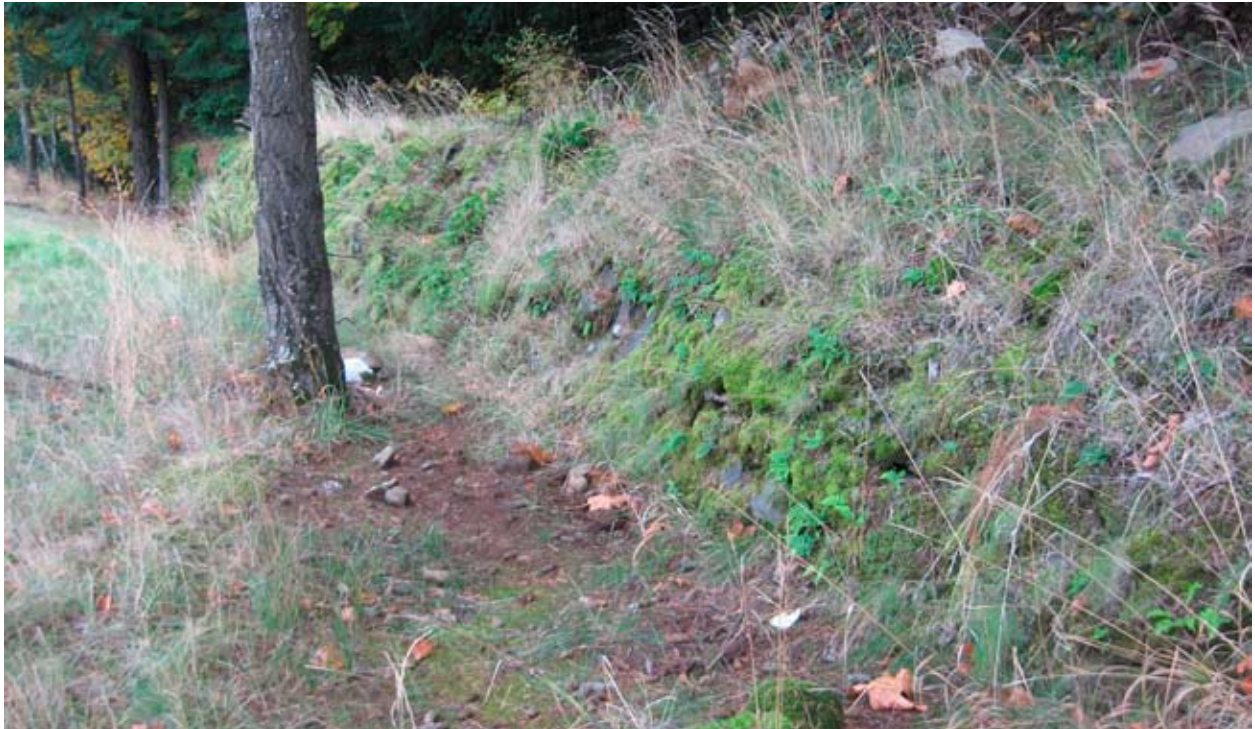
Retaining wall north of Historic highway. This may be part of a longer wall. It is damaged by the ferns and other vegetation, missing chink stones.

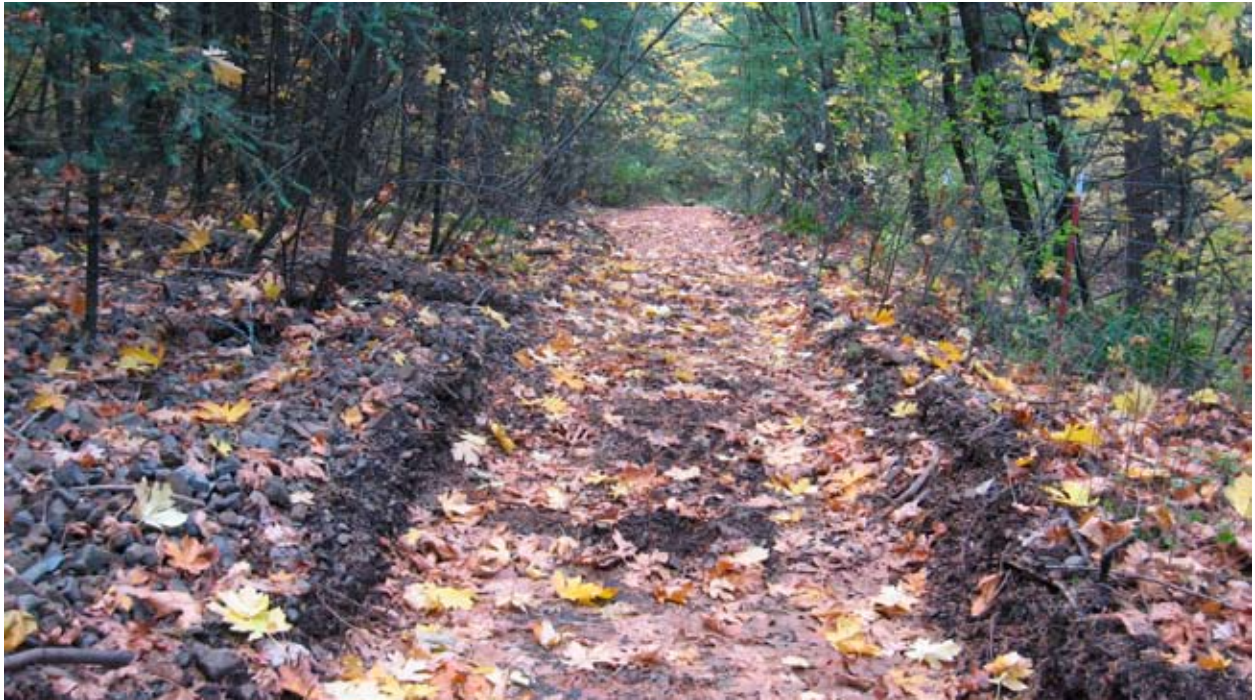
Washed out, buried road bed, Viento Segment 1. Contemporary wire fence on right.

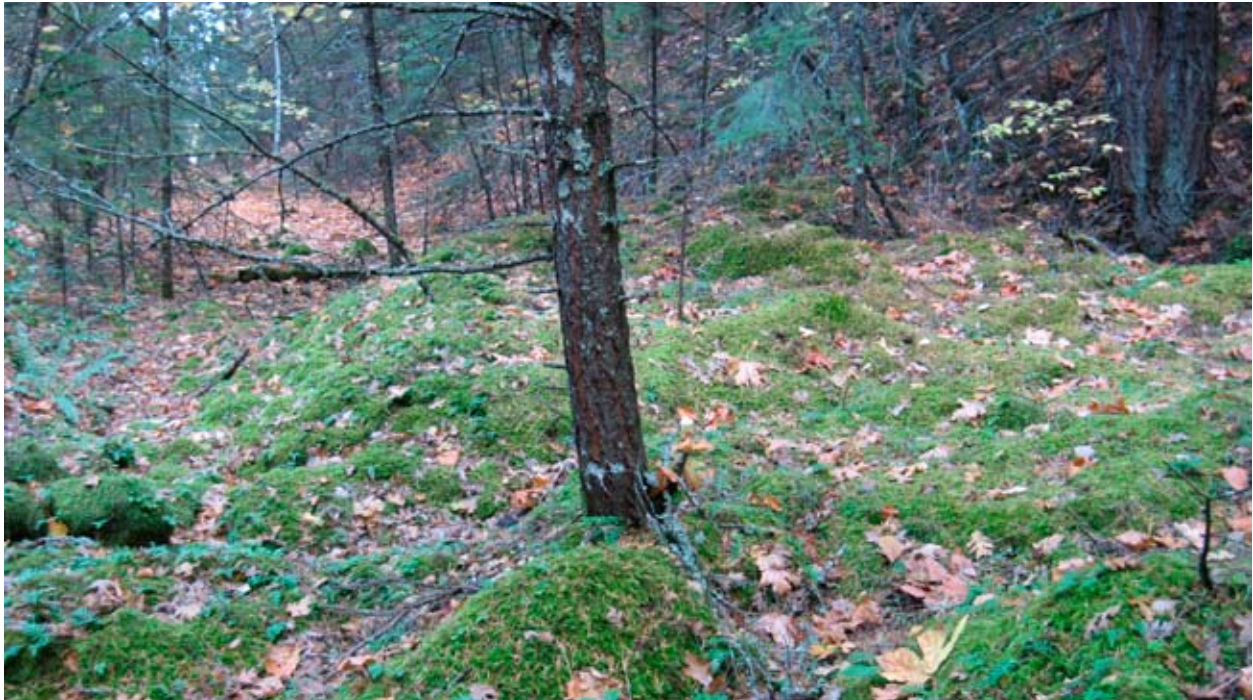
Pile of asphalt and rubble from removed roadbed, Viento Segment 3. The roadbed in the background has buried, fragmented pavement in poor condition, overgrown vegetation.

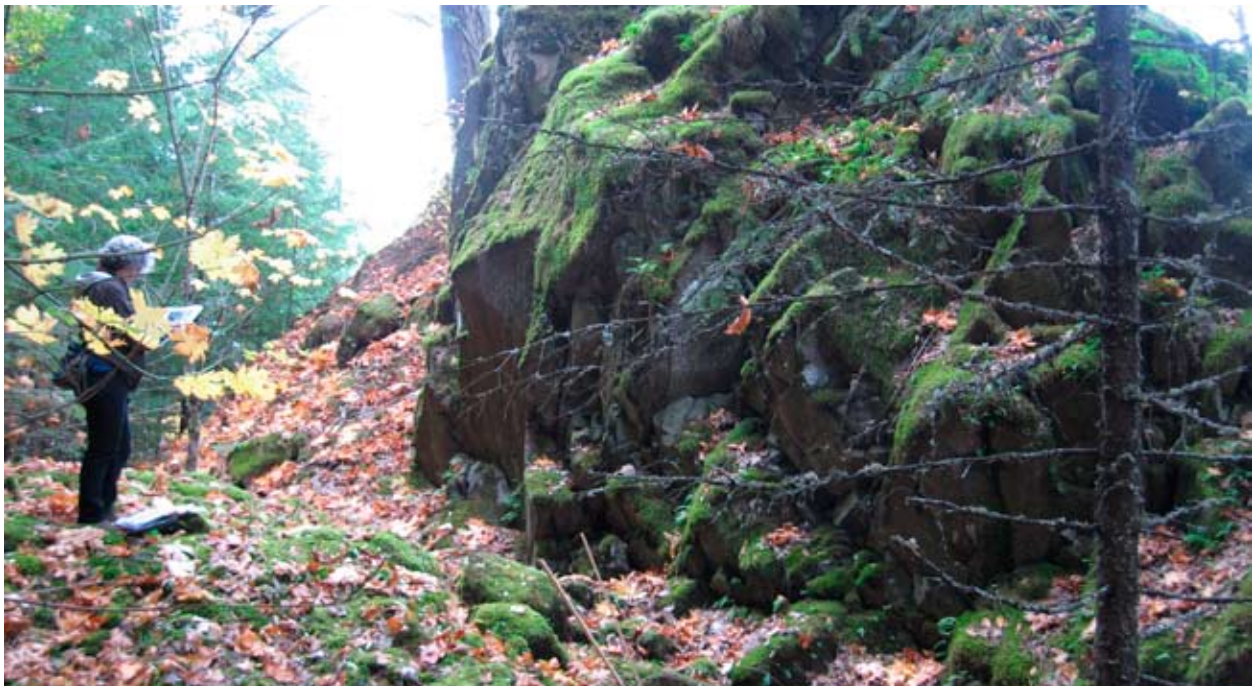
Rock Cut, associated with cut-through, Viento Segment 3. The roadbed is piled with asphalt.

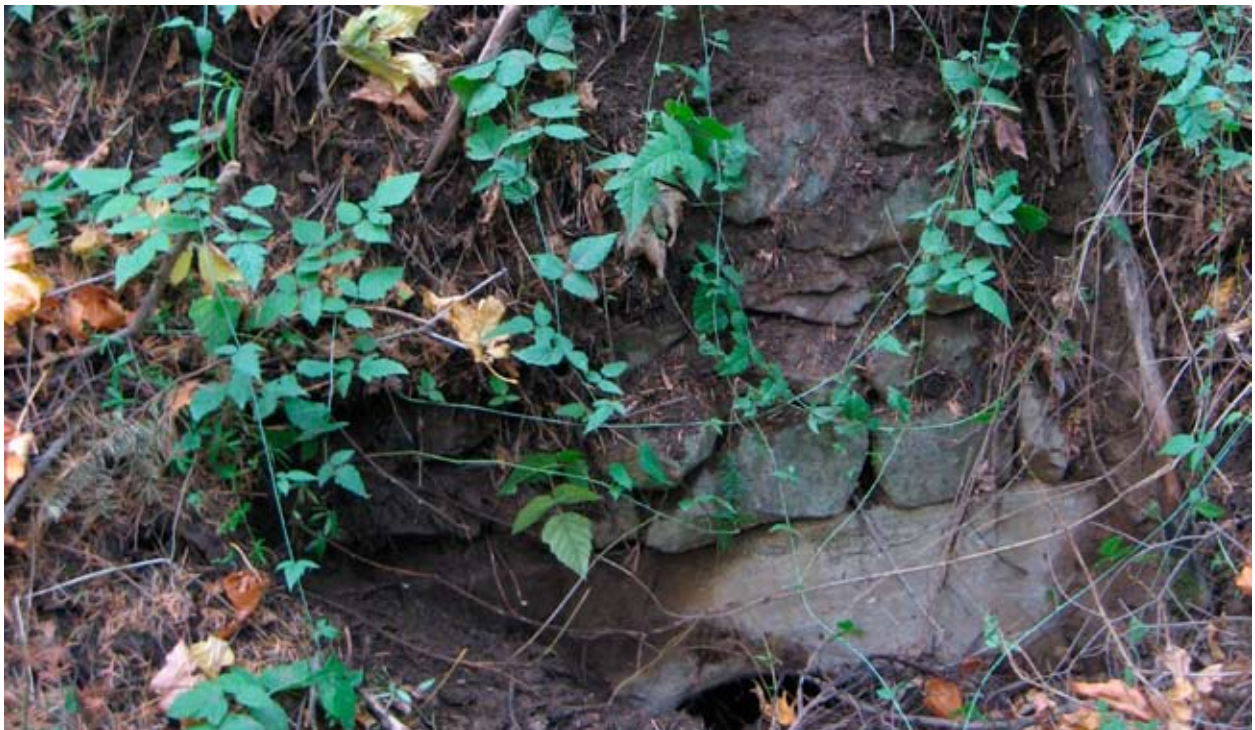
Clogged concrete culvert, Mitchell Point Segment 2

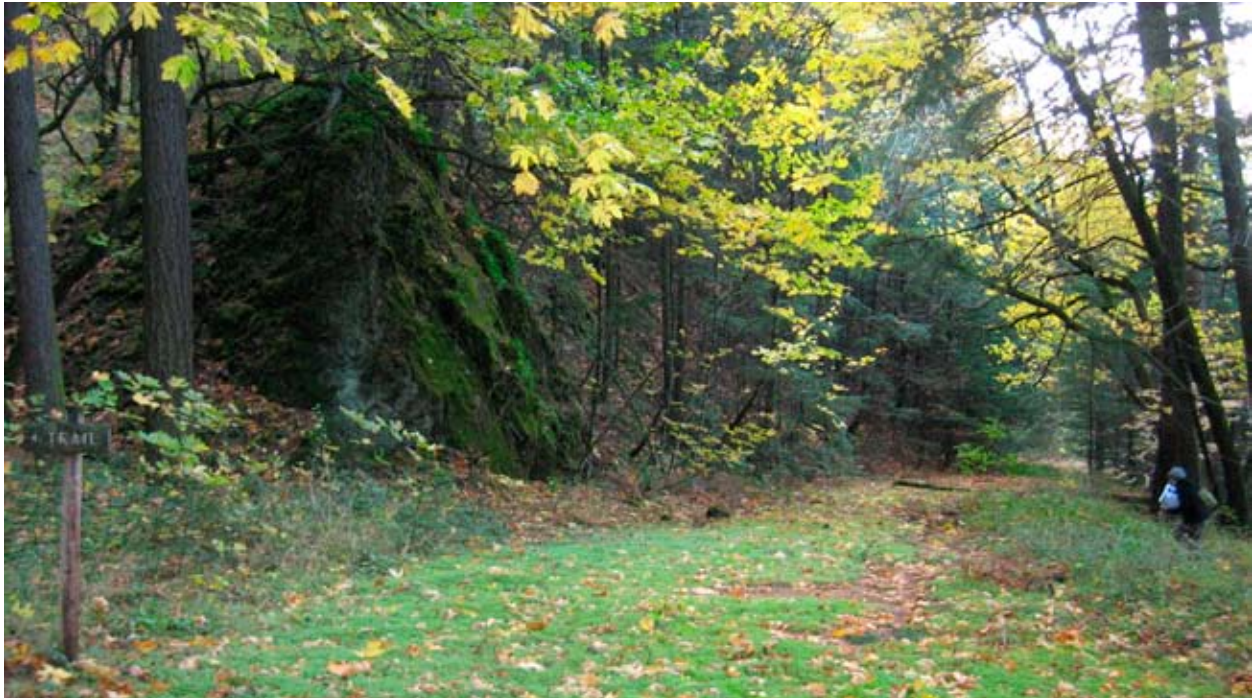
Mitchell Point Segment 2, Wyzant trail intersection. Overgrown pavement, clogged drainage system.

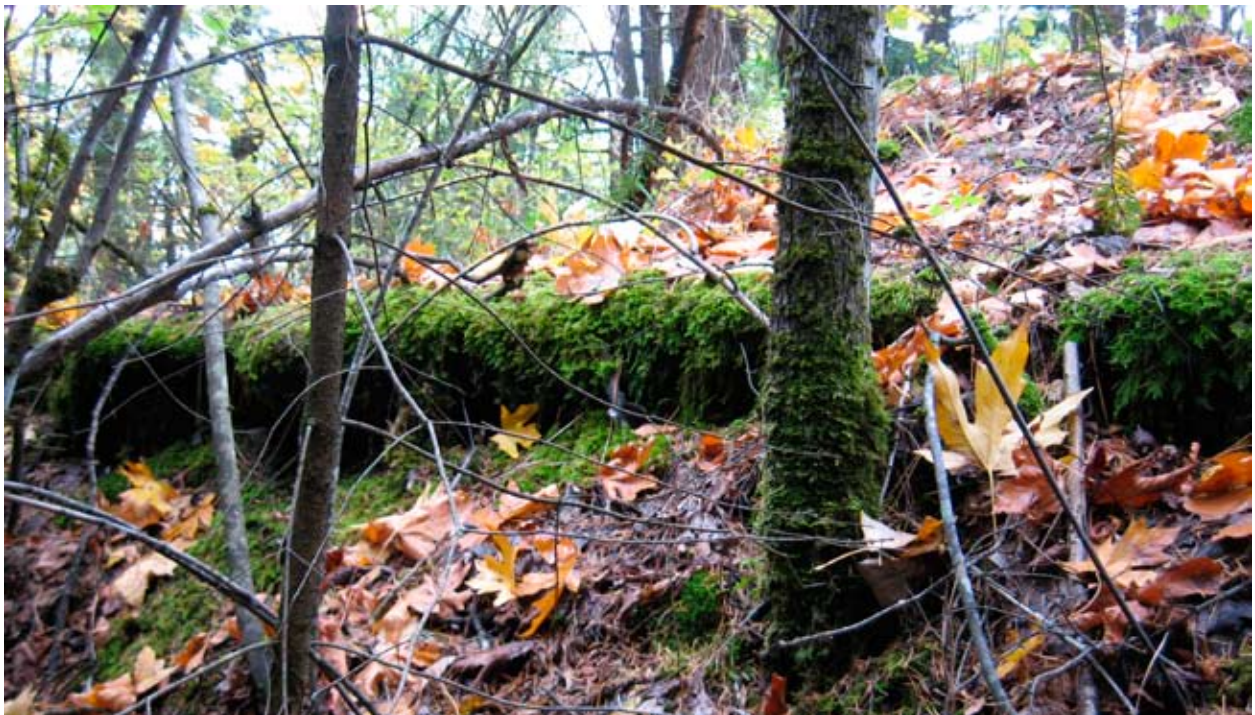
Pavement edge, washout at Mitchell Creek, Mitchell Creek Segment 2

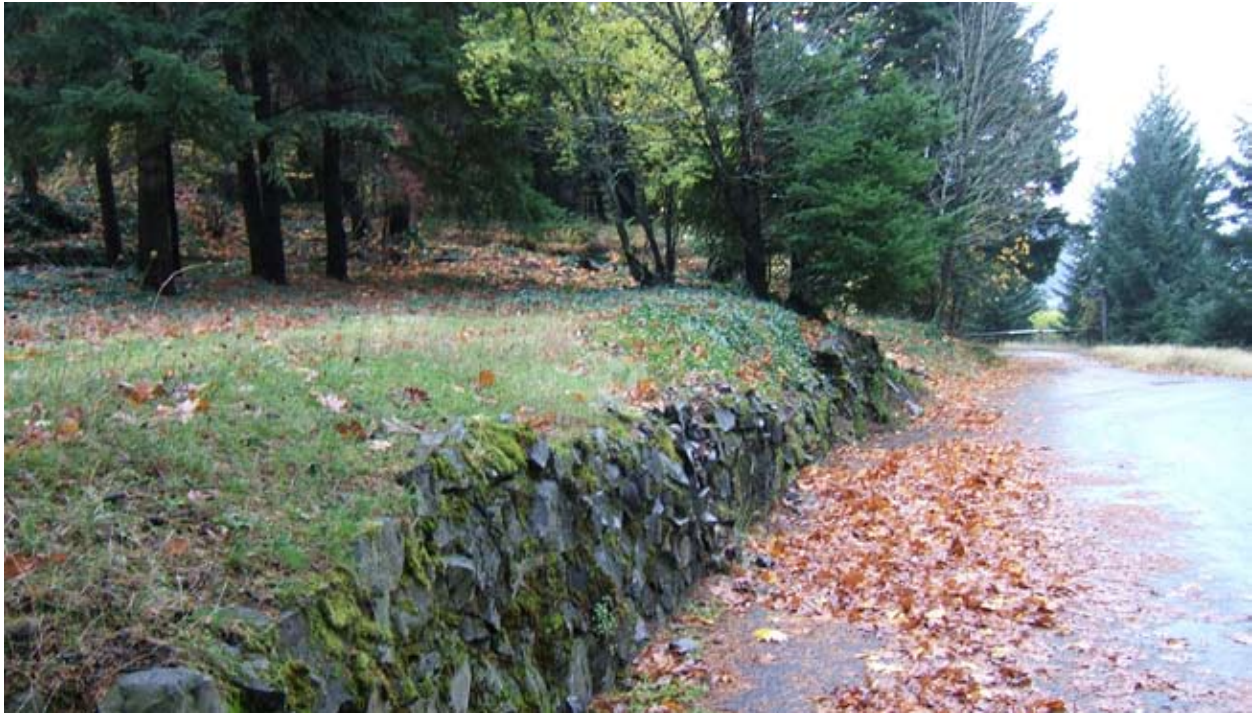
Mitchell Point Segment 3, retaining wall and settlement site from parking lot. The wall has failed and been patched with mortar and rubble.

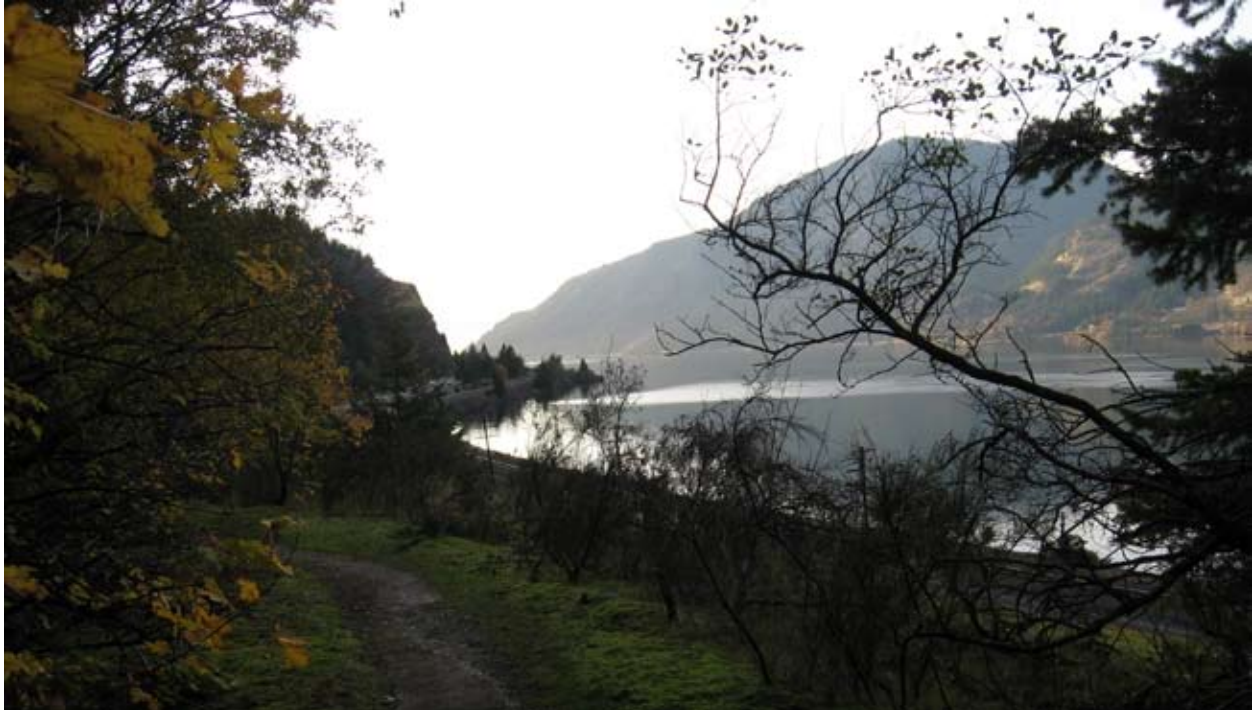
Partially missing pavement, contemporary view, Mitchell Point Segment 2.

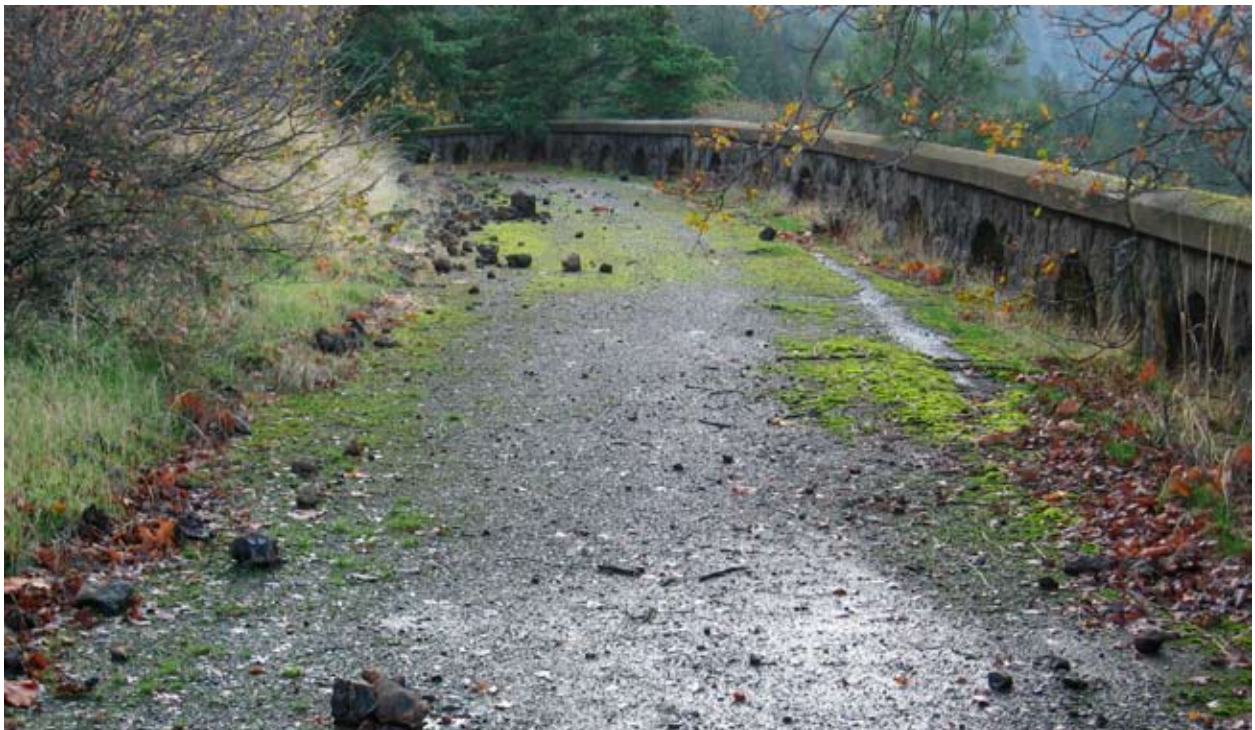
Reconstructed and repaired rubble masonry parapet, damaged and partially buried roadbed, Ruthton Point
