CULTURAL LANDSCAPE INVENTORY:
SHELLROCK MOUNTAIN TO RUTHTON POINT

HISTORIC COLUMBIA RIVER HIGHWAY

Prepared For:
Oregon State Department of Transportation

January 2010

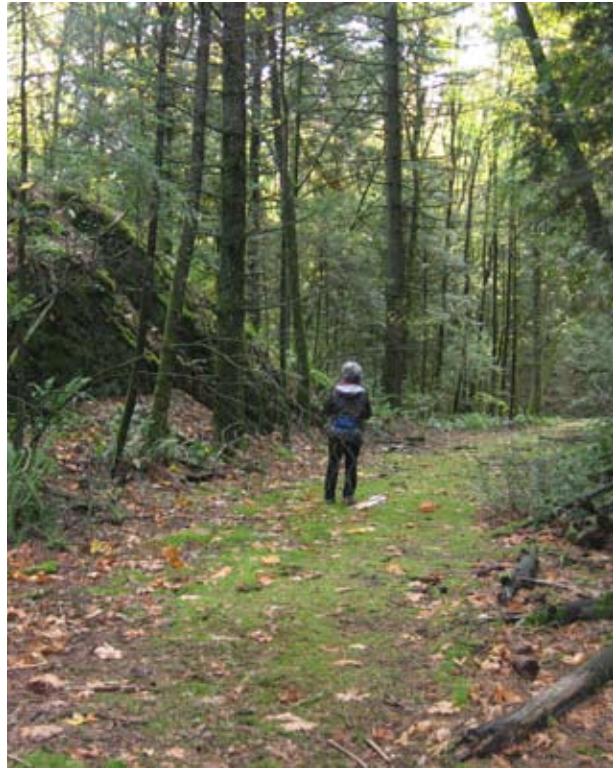
Cut through, Lindsey Creek

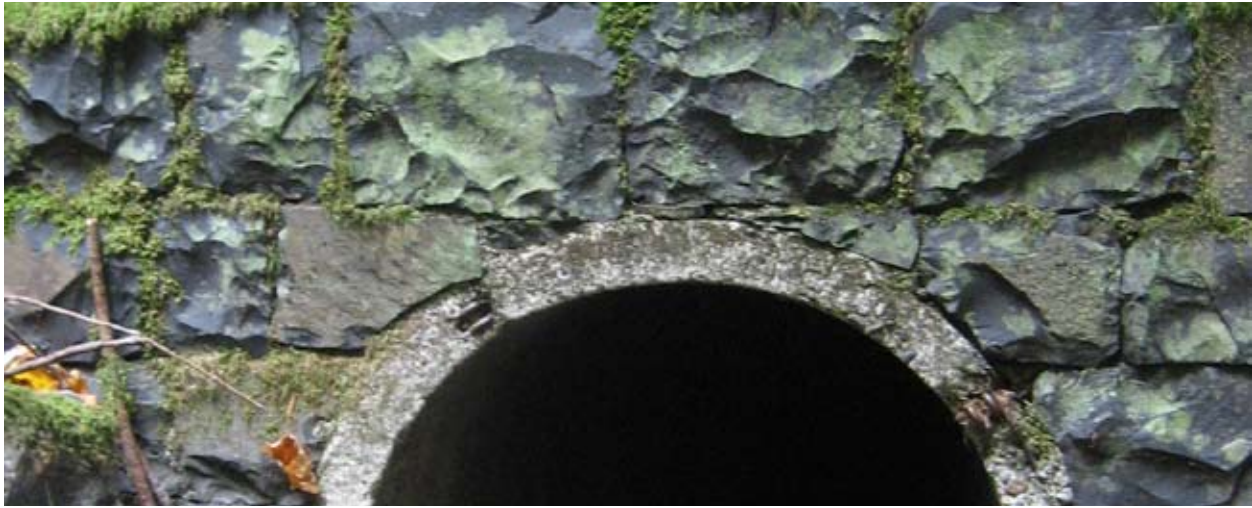
Cabin Creek culvert detail. The basalt stones on this culvert would be described as medium sized, hewn, bossed (shaped to have a convex face), laid in straight courses, dry laid with mortar around the pipe.

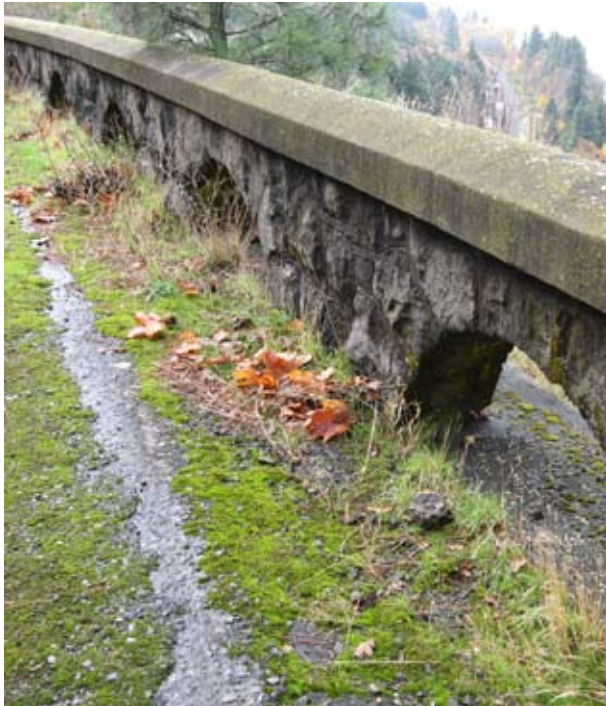
Restored Masonry Parapet, Ruthton Point

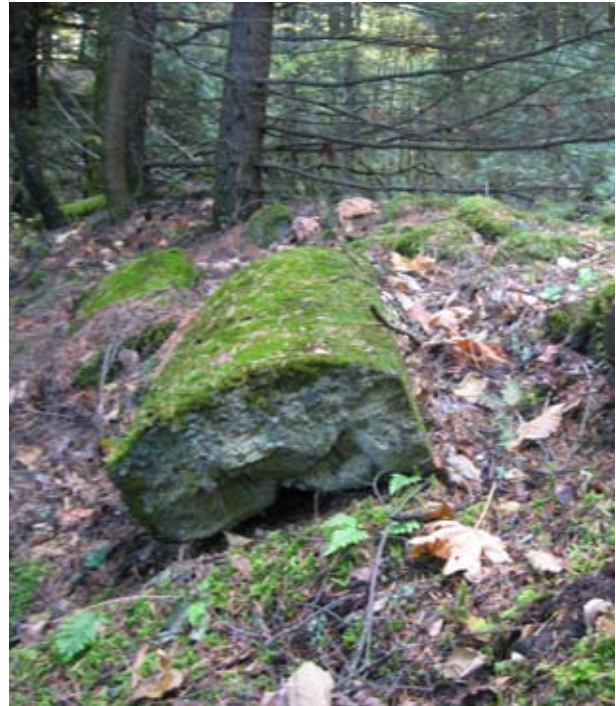
Collapsed Masonry Parapet, Lindsey Creek

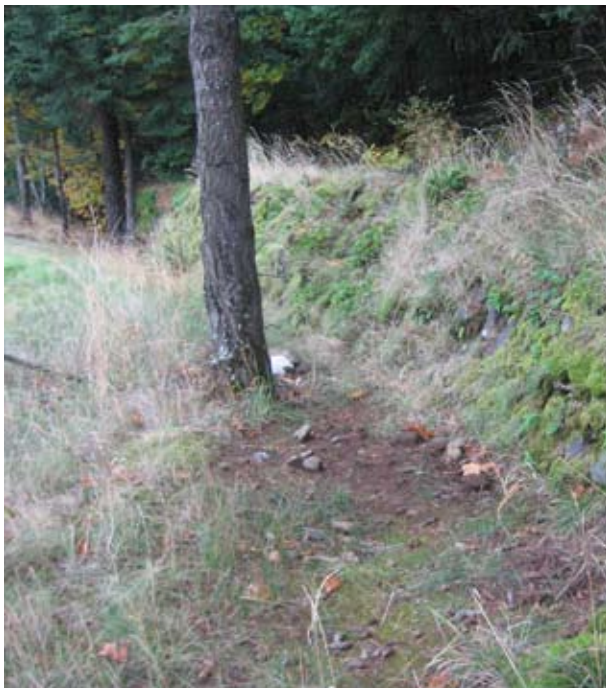
The inventory recorded a 270-foot long retaining wall in below the road on the north side of the highway, in the area of Cabin Creek. It is a typical coursed, dry laid stone retaining wall, with a mortar cap. The wall is in poor condition, with a crumbling mortar, some missing stones, and missing chink stones. It is overgrown with vegetation. The mortar cap may be a later addition.

Retaining Wall, Cabin Creek Area

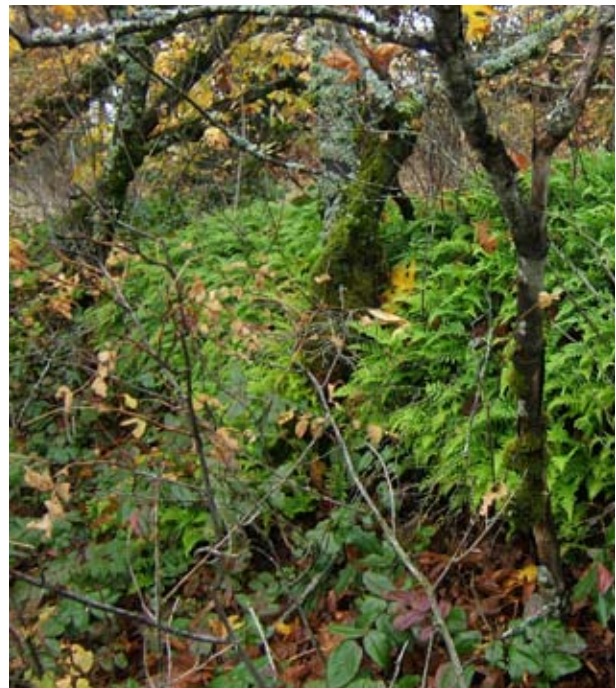
Retaining wall, Ruthton Park

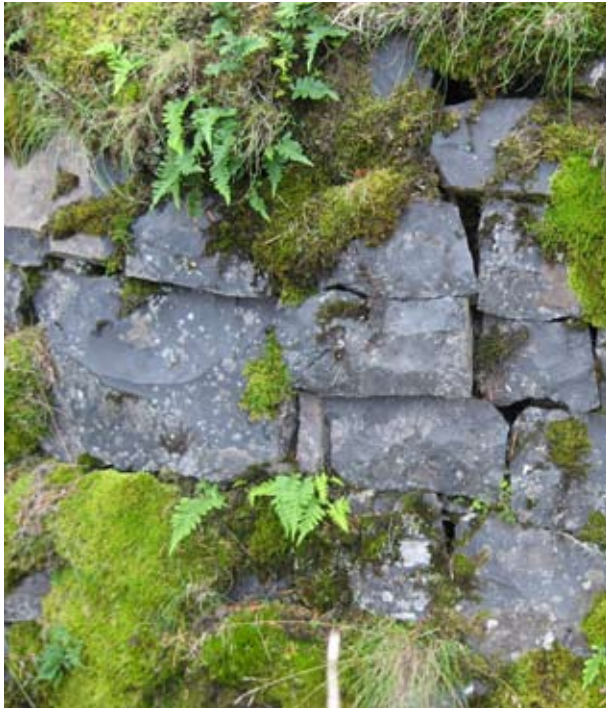
Detail, Cabin Creek retaining wall

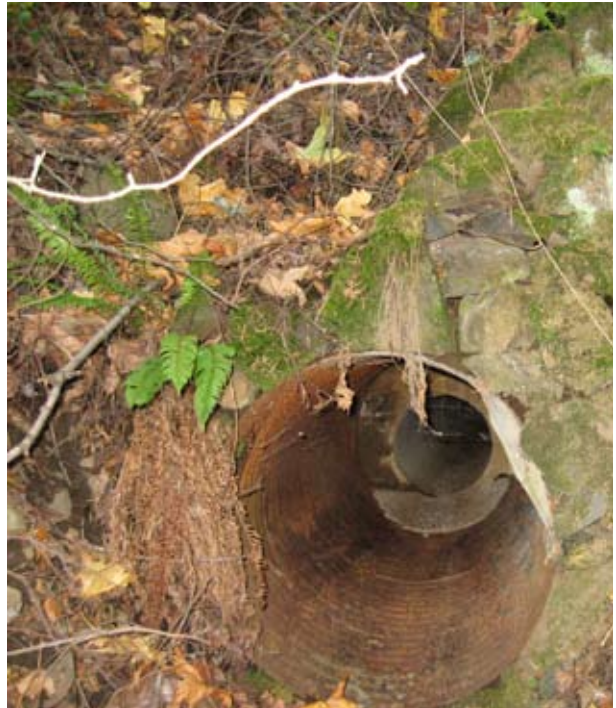
Culvert, rubble wall, Mitchell Point 2

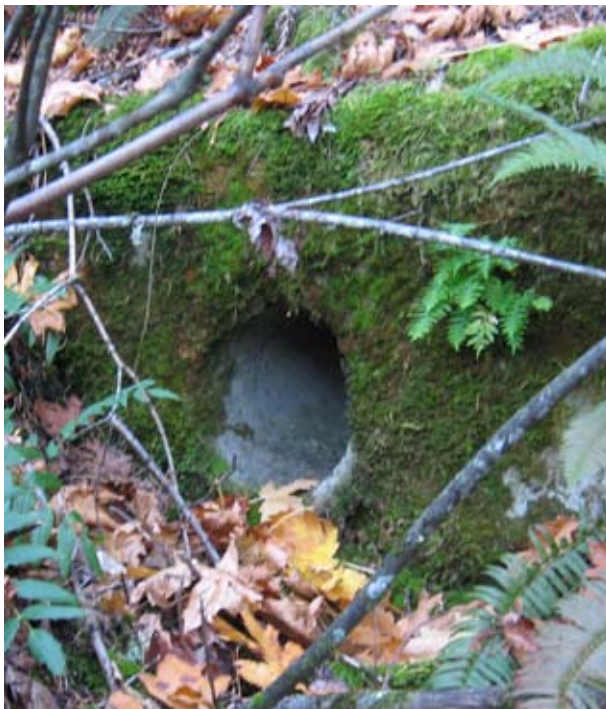
Concrete culvert, concrete head wall, Mitchell Point 2

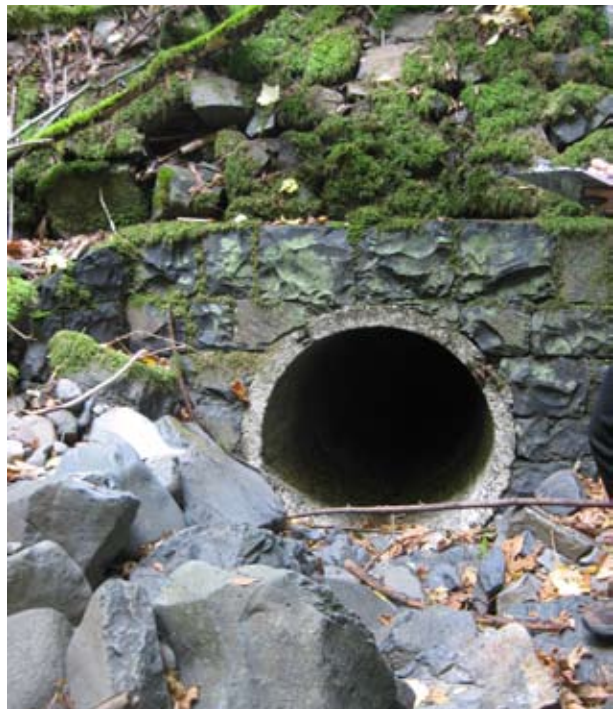
Cabin Creek culvert

Drainage structures along the segments included in the inventory are almost all buried or washed out, and it was not possible to relocate them within the scope of this project. Some potentially could be relocated from the road log. The inventory found five culverts, all in poor condition. All but one appeared to be clogged, and one to have been repaired or extended with corrugated steel pipe. At Cabin Creek, the culvert is clearly designed to be seen from the path up to the falls, with a hewn, bossed basalt head wall on the inlet side, topped by a rubble wall. Another culvert in the same segment located from the historic road log includes a dry laid stone head wall. This culvert also has a stone rim on the concrete pipe.

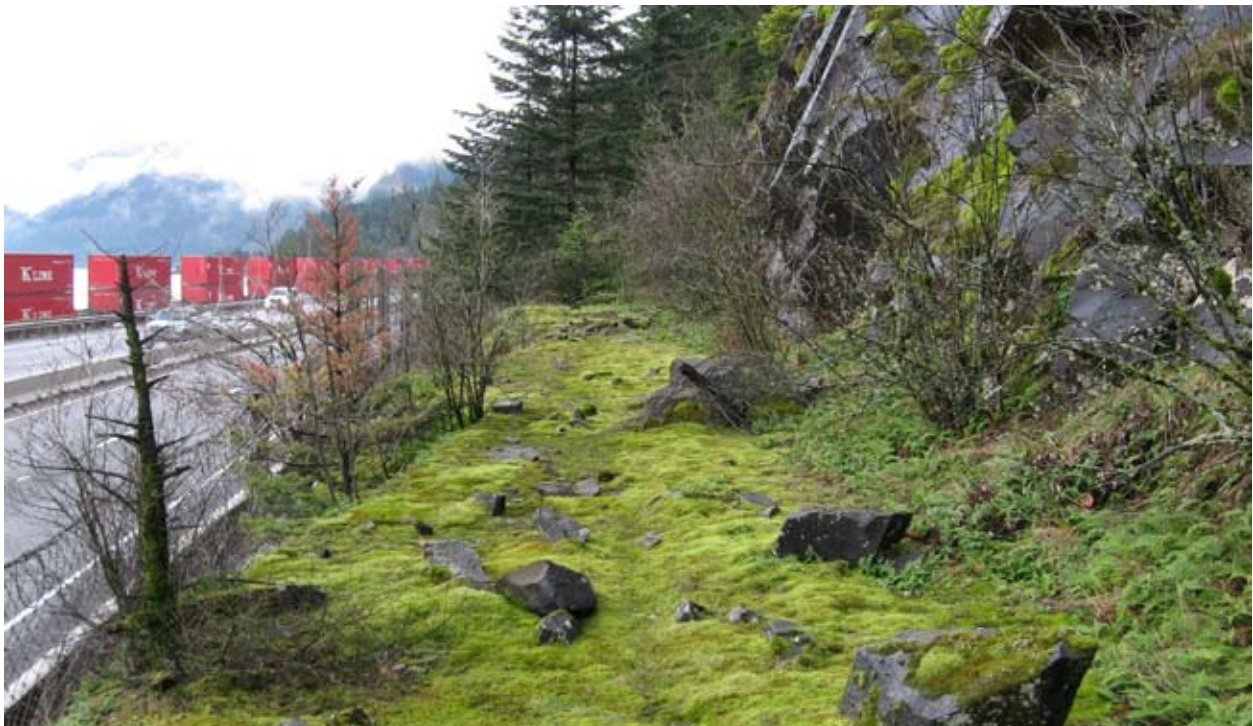
Only a two fragments of HCRH pavement remain in the Shellrock Mountain section. The largest is a stretch of about 700 feet, consisting of part of the roadbed, the north edge broken off by I-84 and the south edge hidden by rock fall and vegetation. The pavement itself is buckled, patchy, and overgrown with trees, shrubs and moss. In other areas there are small patches of asphalt and heaps of asphalt piled in the roadbed. There is a trail in poor condition connecting to the military wagon road that intersects the alignment of the HCRH at its east end.

HCRH roadbed and rock cut, Shellrock Mountain

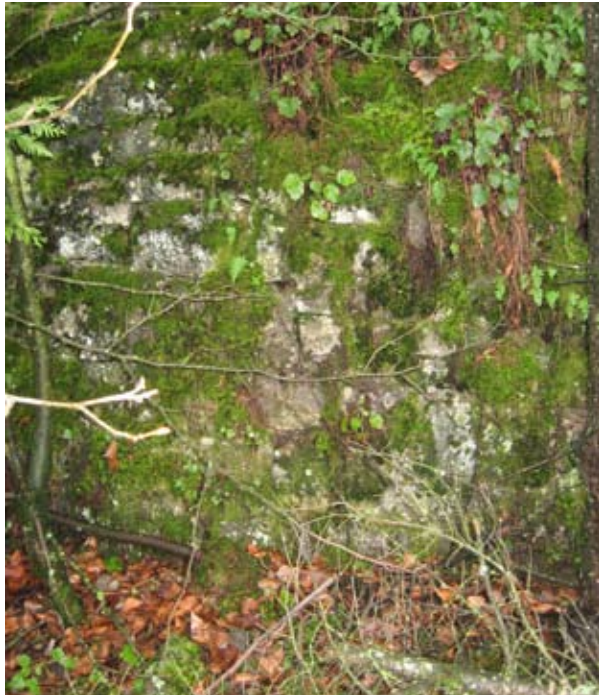
masonry parapet are piled along the top of the wall, and talus has accumulated there as well. These wall fragments reveal how thick this retaining wall is, and the size of the stones used in it. The second retaining wall, located about two thousand feet east of the first, is about 150 feet long and 10 feet high, but like the first the top is broken or missing in places. The stones are hewn basalt, laid in a random arrangement with some mortar at least at the top. This second wall is buried in vegetation and overgrown with trees. It is in poor condition, but impressive nevertheless.

Retaining wall, Shellrock Mountain

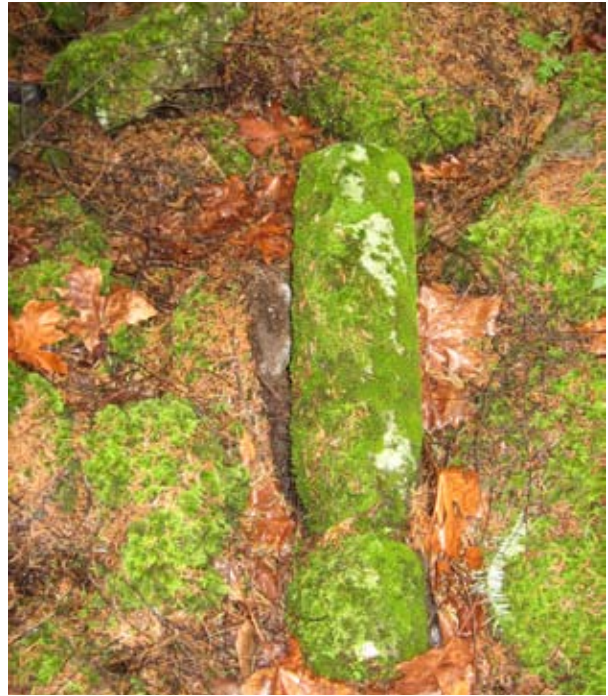
Archaeological features identified by the inventory survey include remains of concrete guard rail from the 1940s and concrete rubble by the side of the road, the original location of the plaque commemorating the “honor men” who built the road replaced by the HCRH.

Concrete guard post, Shellrock Mountain

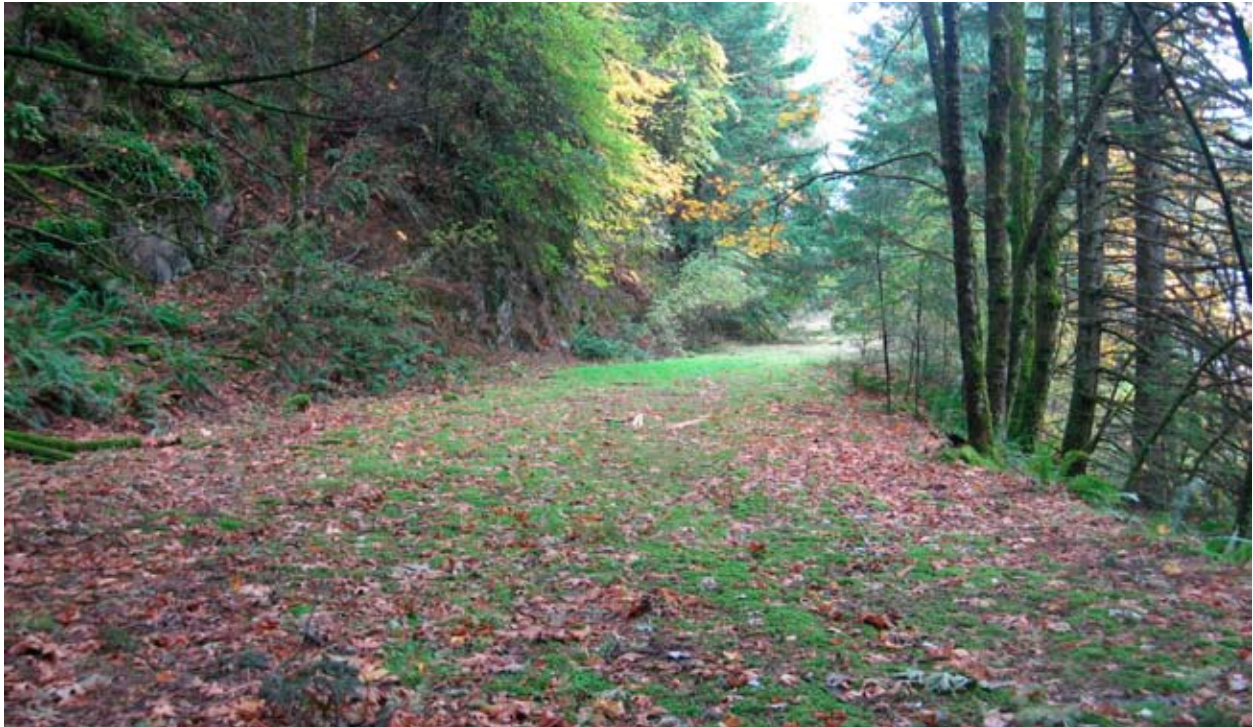
The roadbed of the historic highway is covered in a few inches of duff and moss through out the fragment. Below this layer, the pavement appears to be in good condition, with the centerline still apparent. There are three wye intersections with

Road surface, alignment, rock cut. Lindsey Creek Segment.

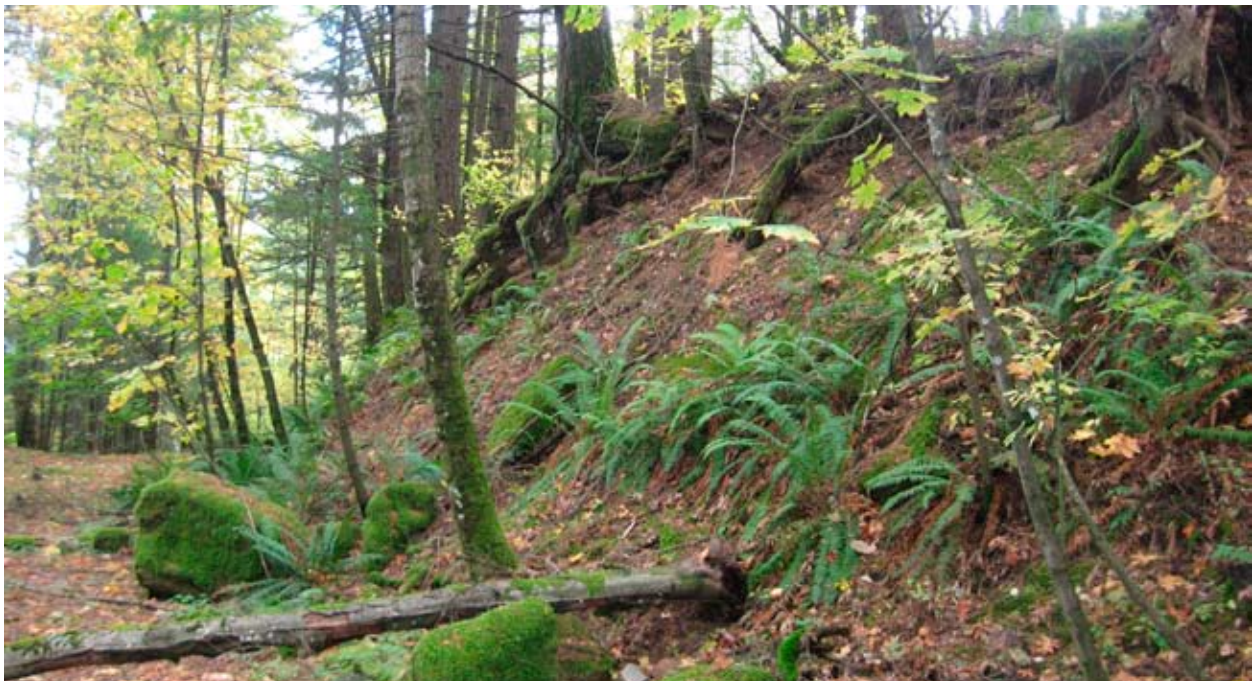
The rock cuts in this section are in fair condition, compromised by some minor rock fall and slides, accumulation of soil in gutters, and small trees and other vegetation along the road edge. The large rock cut at the eastern end was not evaluated as it is past the end of the fragment and inaccessible. There are three fill-throughs. Two are in fair condition, with blocked drainage structures. One is in poor condition, with blocked drainage and overgrown vegetation. The two cut-throughs in the fragment are both in fair condition. They are overgrown with vegetation and sapling trees, and one of them has formed an eyebrow of soil undercutting its top edge, compromising the stability of trees above. Both cut throughs have some slumping or rock fall into the roadbed.

Cut-through, Lindsey Creek Segment. The eyebrow of this cut is compromising the trees and integrity of the slope. Fallen rocks and vegetation are also damaging.

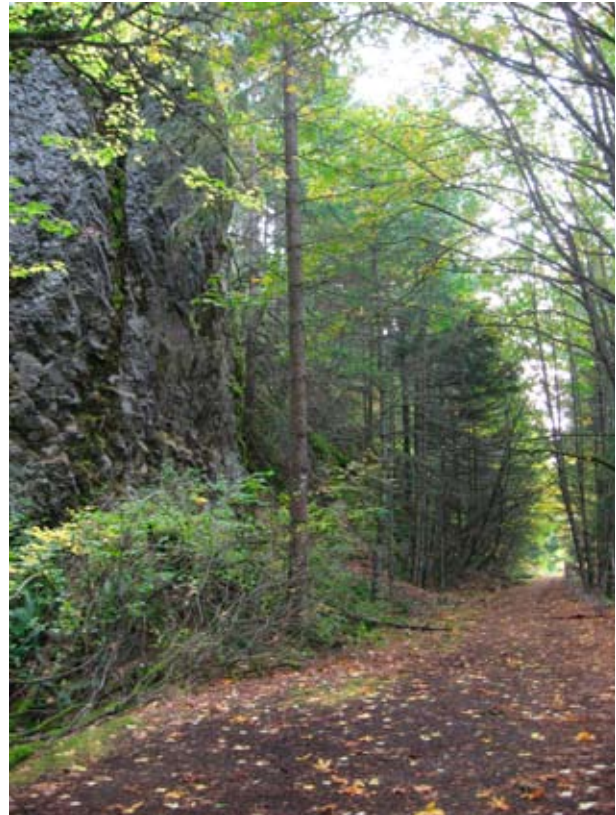
Cabin Creek area, Starvation Creek Segment. Overgrown vegetation along road edge, slide (right, background), debris and mud build up on edges of the road surface.

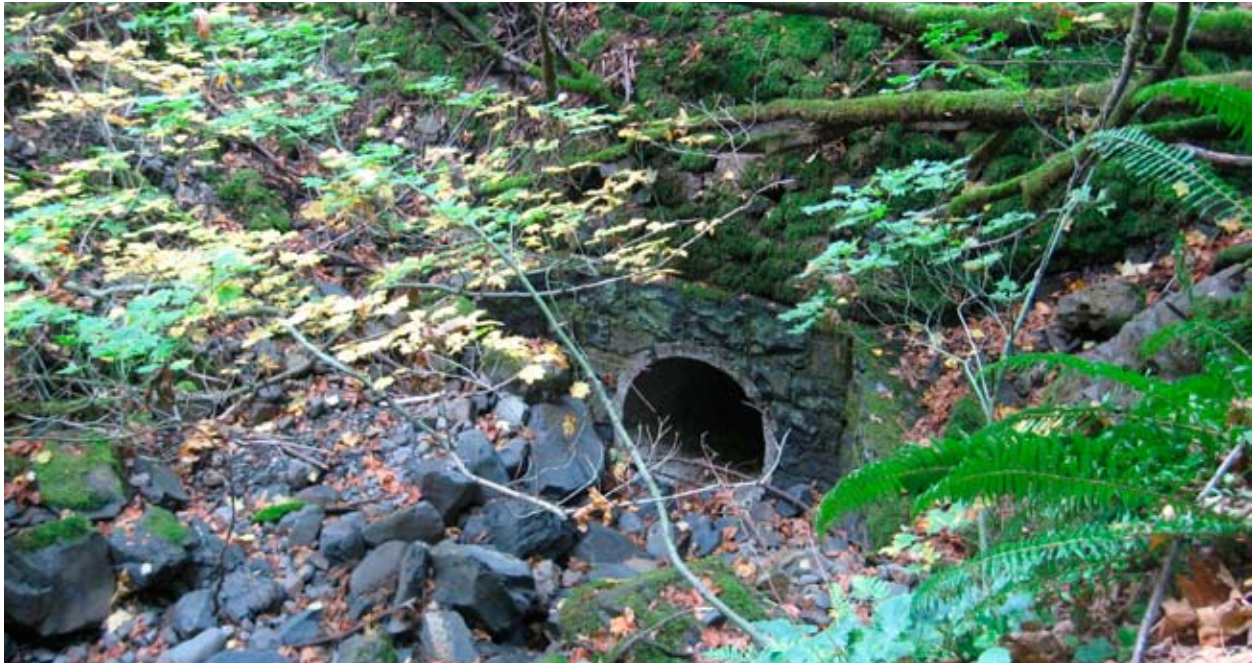
segment. The Cabin Creek culvert was designed to be seen from the trail to the Falls, and consists of 36" concrete culvert set in a six foot wide headwall of coursed basalt stones that have been hewn and bossed, laid with mortar. Above and to the sides of the mortared headwall is a continuation and wing walls of unhewn, dry laid rubble wall. This rubble wall appears to have been repaired or modified at some time. Because of these modifications and some missing stones, the culvert is considered to be in poor condition. A second concrete culvert with basalt stone detailing around the mouth is in poor condition because it is almost entirely buried and clogged.

Cabin Creek culvert. The style of this culvert suggests it was meant to be seen from a path to the fall.

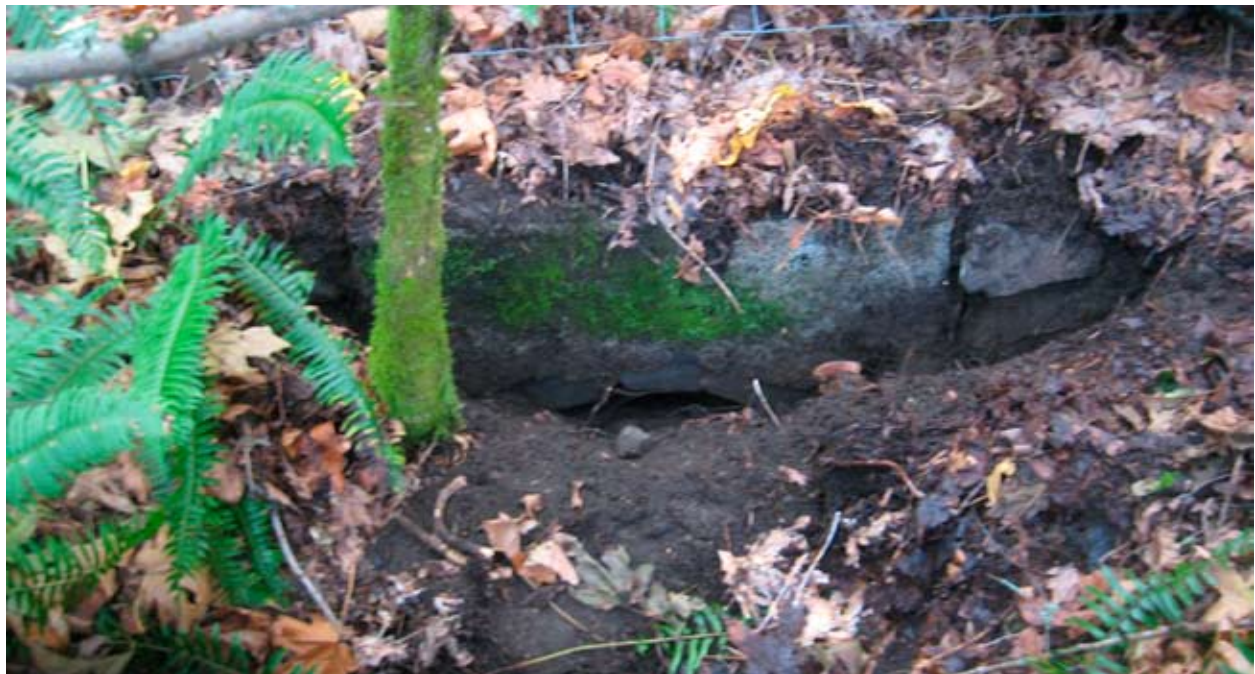
Buried, clogged culvert, Starvation Creek Segment

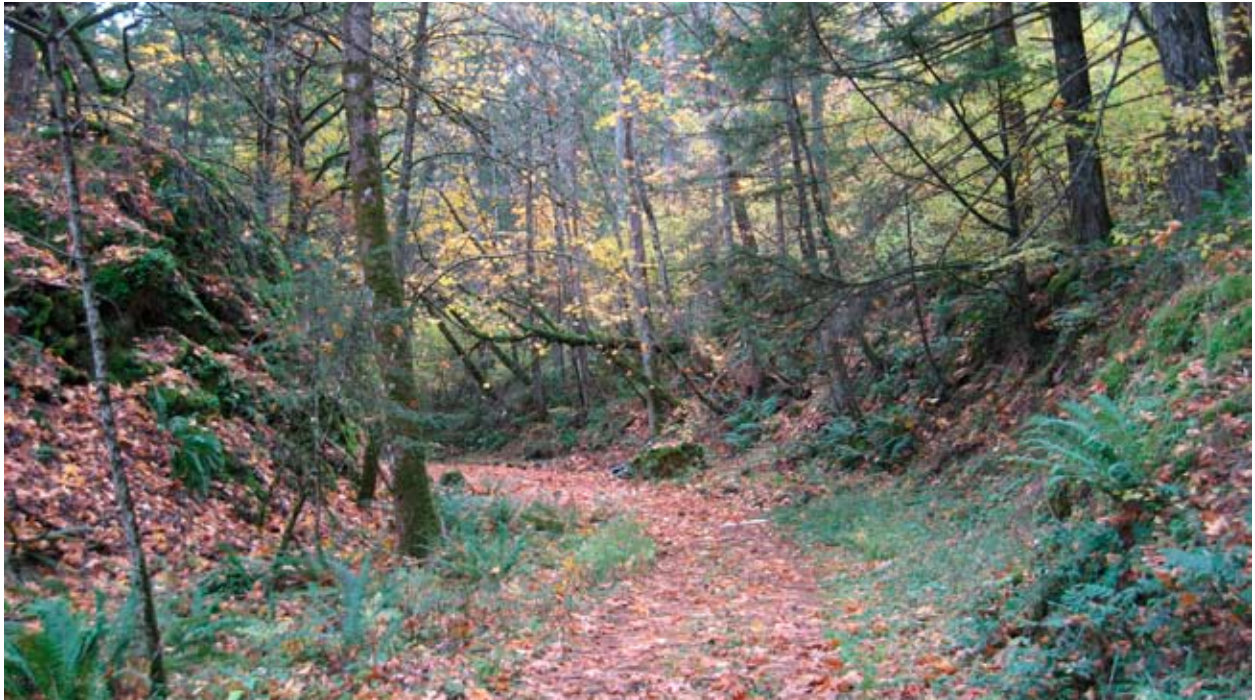
The first segment of road runs through a relatively flat area at the base of the rocky point to the east of Viento Creek. At the start of the segment is a rock cut associated with this point. It is in poor condition, with debris and boulders slumping into the roadway and vegetation filling in the road edges. The rock cut forms the north side of

Cut through with rock cut, Viento Segment 1.

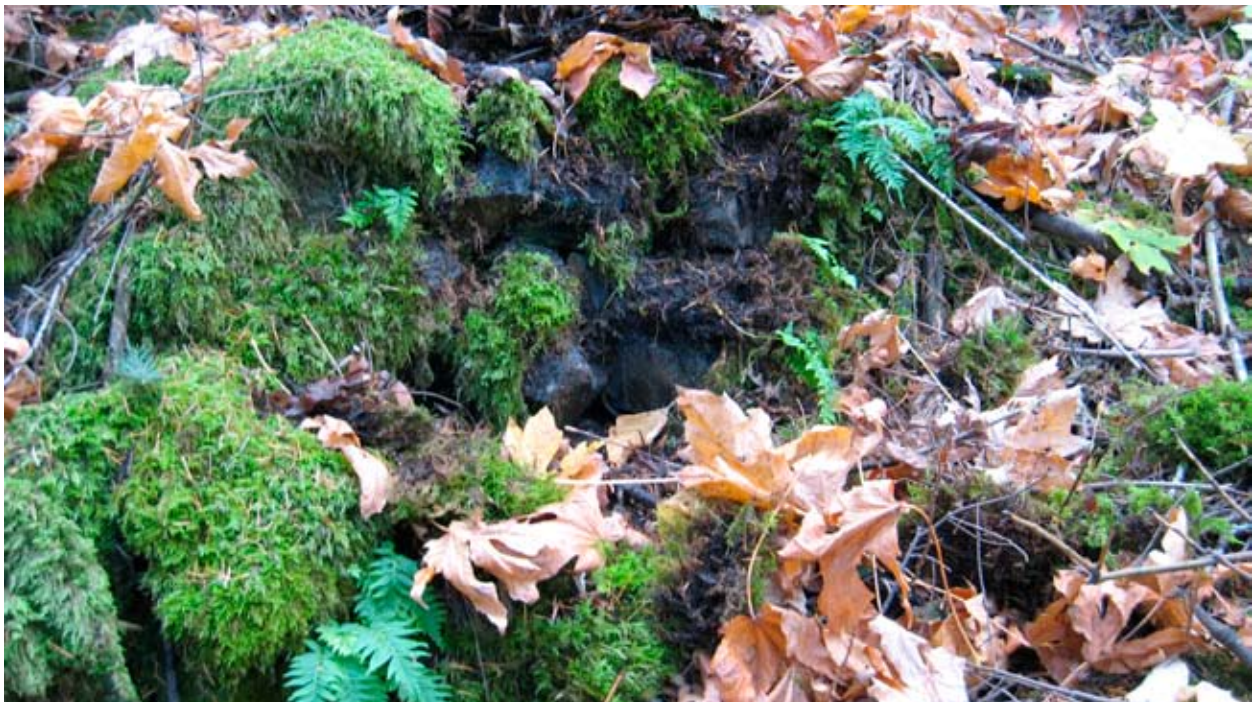
The roadbed east of the Viento State Park maintenance yard has what may be a very badly deteriorated battered stone retaining wall in places on its north side. Some of the stone here may simply be rubble fill forming the roadbed. There is a contemporary wire and steel post fence along the road edge, in fair condition most of its length with areas of poor condition. According to the historic road log, there was no masonry parapet in this area, only standard guard fence.

Battered stone retaining wall/ rubble fill. Viento Segment 1.

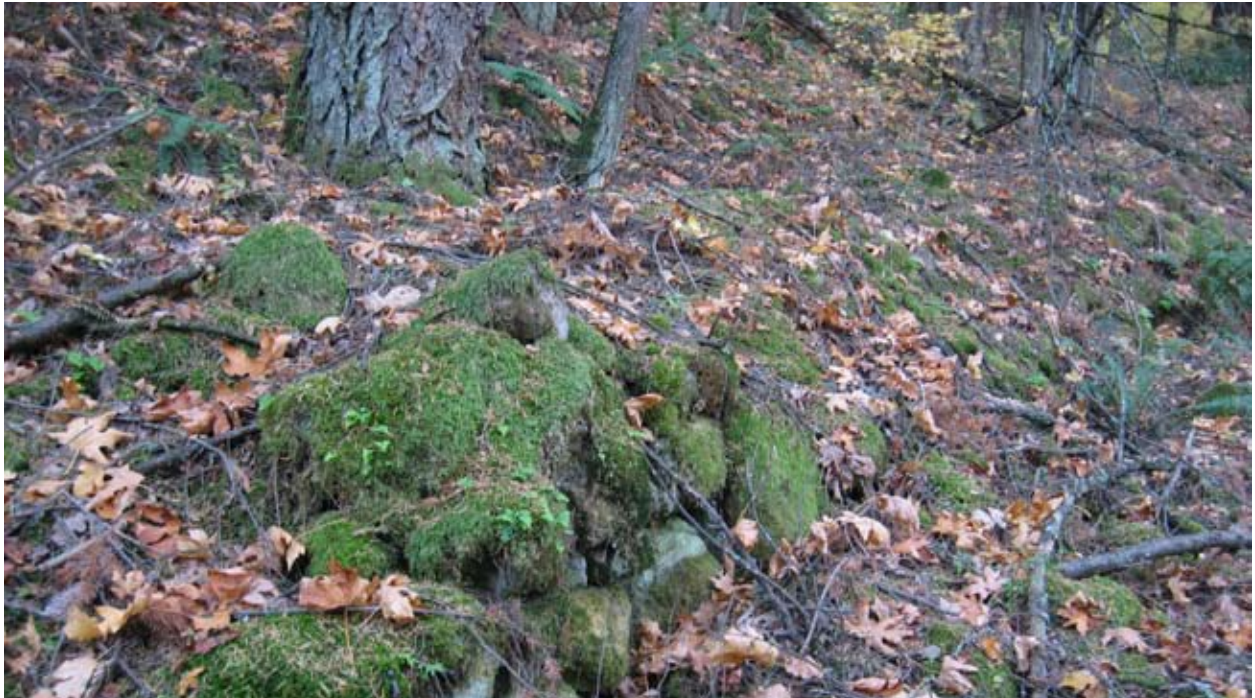
Stone wall and remnant of trail up draw, Mitchell Point Segment 2

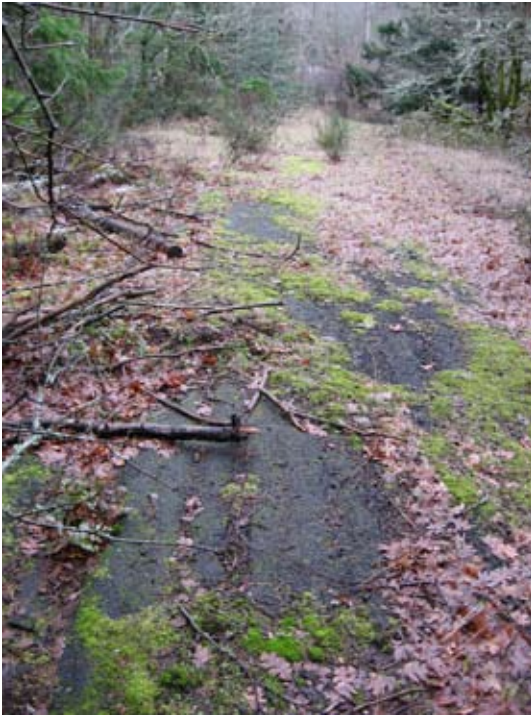
what may be the original alignment of the HCRH. This overgrown and partly buried fragment parallels the current Mitchell point drive. Patches of old asphalt can be found along it.

Possible abandoned alignment HCRH.

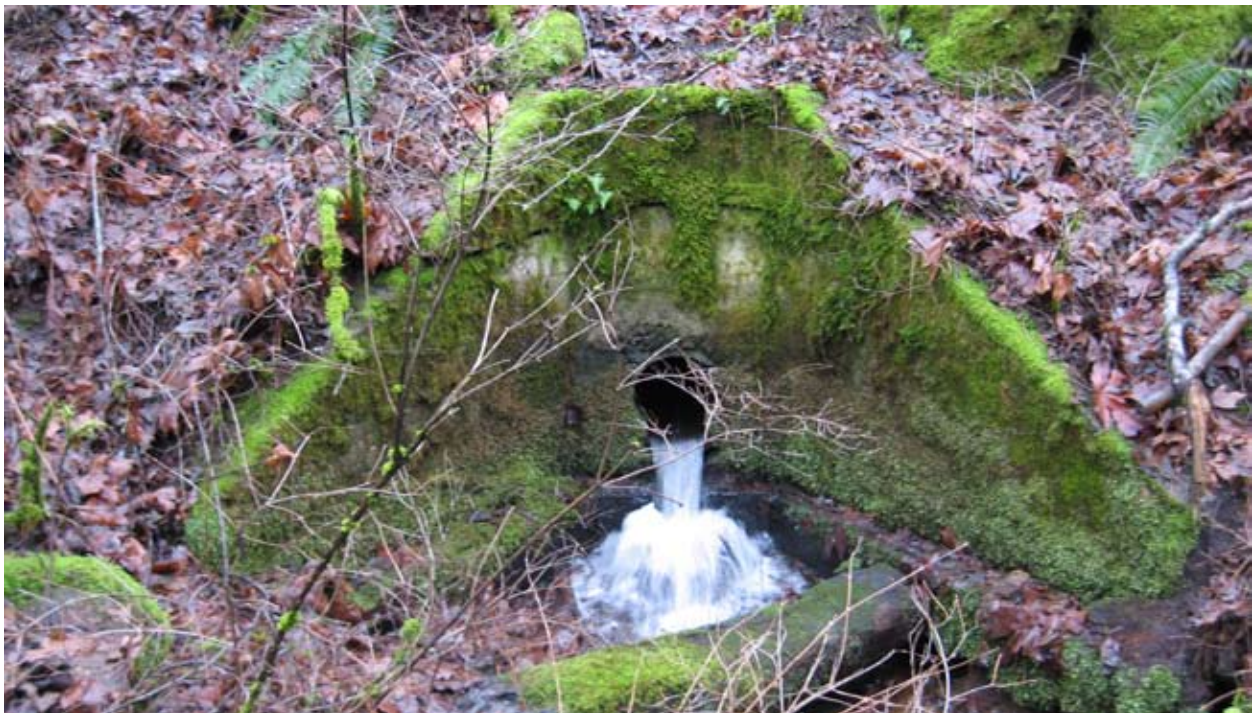
There are few structures remaining that are associated with the roadway. A 12” culvert with concrete head and wing walls in fair condition carries a small seasonal creek under the road.

Concrete culvert headwall, Mitchell Point East.

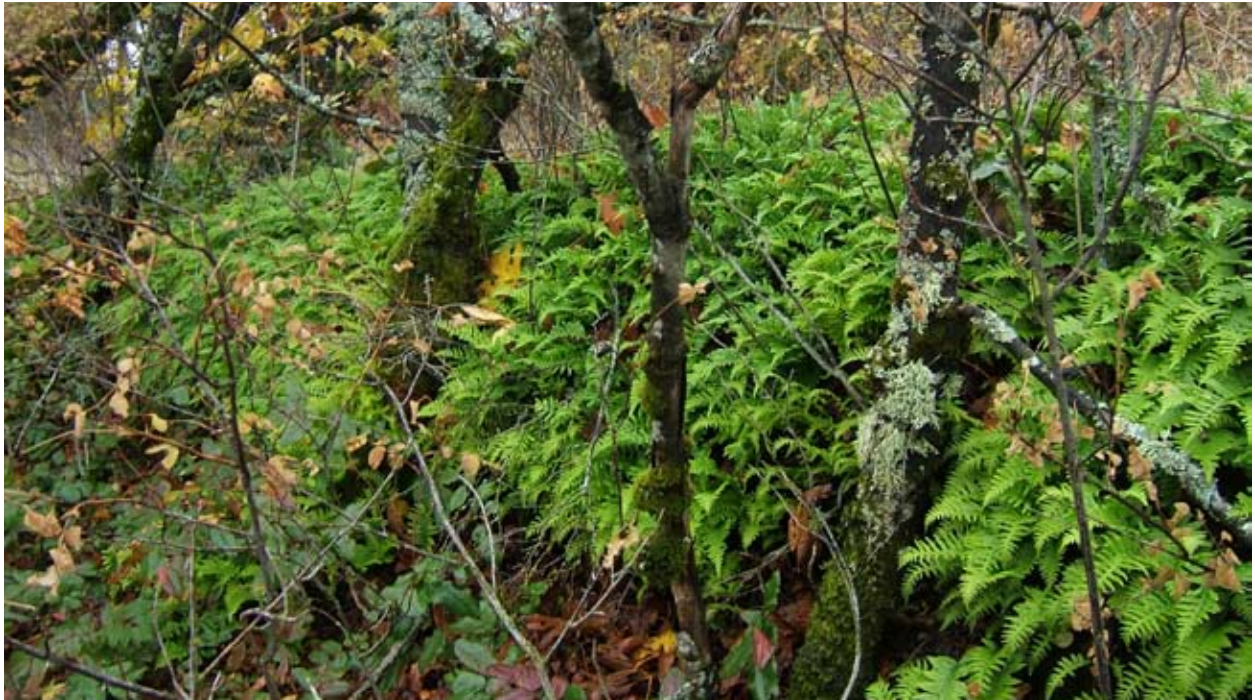
Retaining wall, Ruthton Segment 2.

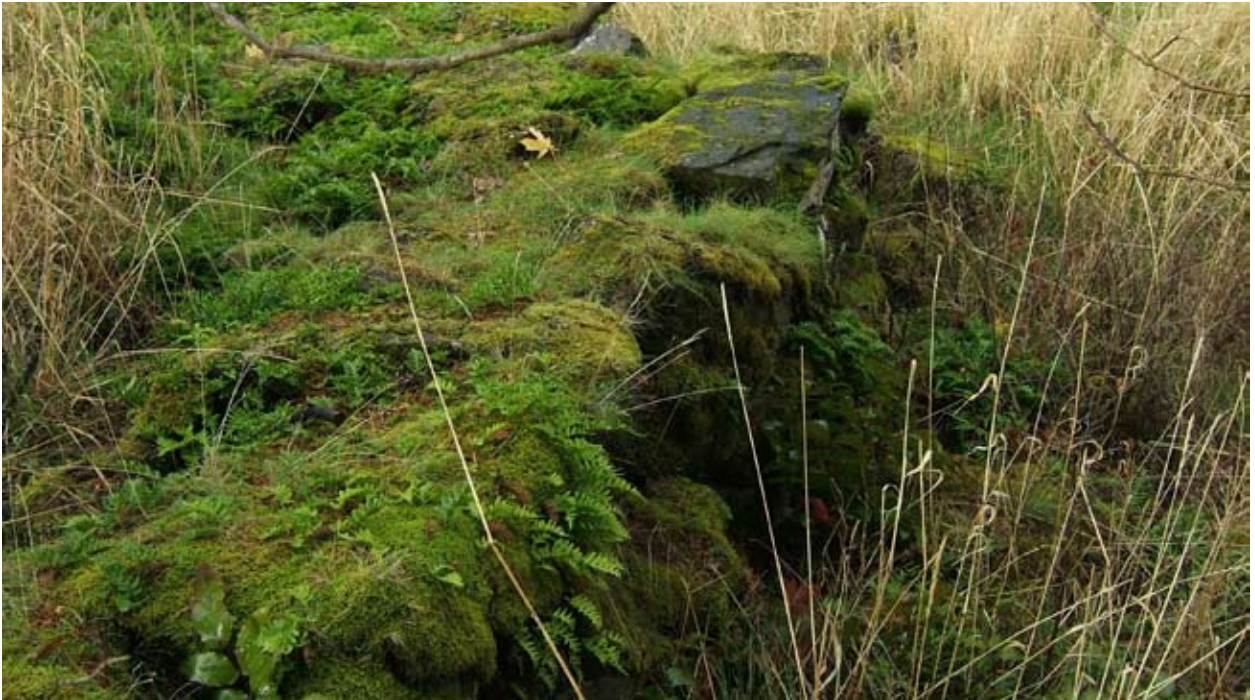
The cliff top adjacent to the Ruthton Park fragment has a rectilinear space and stone remnants that may reflect a previous development. The 1939 aerial shows a building to the east, so this may have been parking or a garden area. There is a stone structure in the drainage between Ruthton Park and the road fragment that may have been a structure associated with the highway, or with the development

Stonework, drainage area, Ruthton Park
