CULTURAL LANDSCAPE INVENTORY:
SHELLROCK MOUNTAIN TO RUTHTON POINT

HISTORIC COLUMBIA RIVER HIGHWAY

Prepared For:
Oregon State Department of Transportation

January 2010

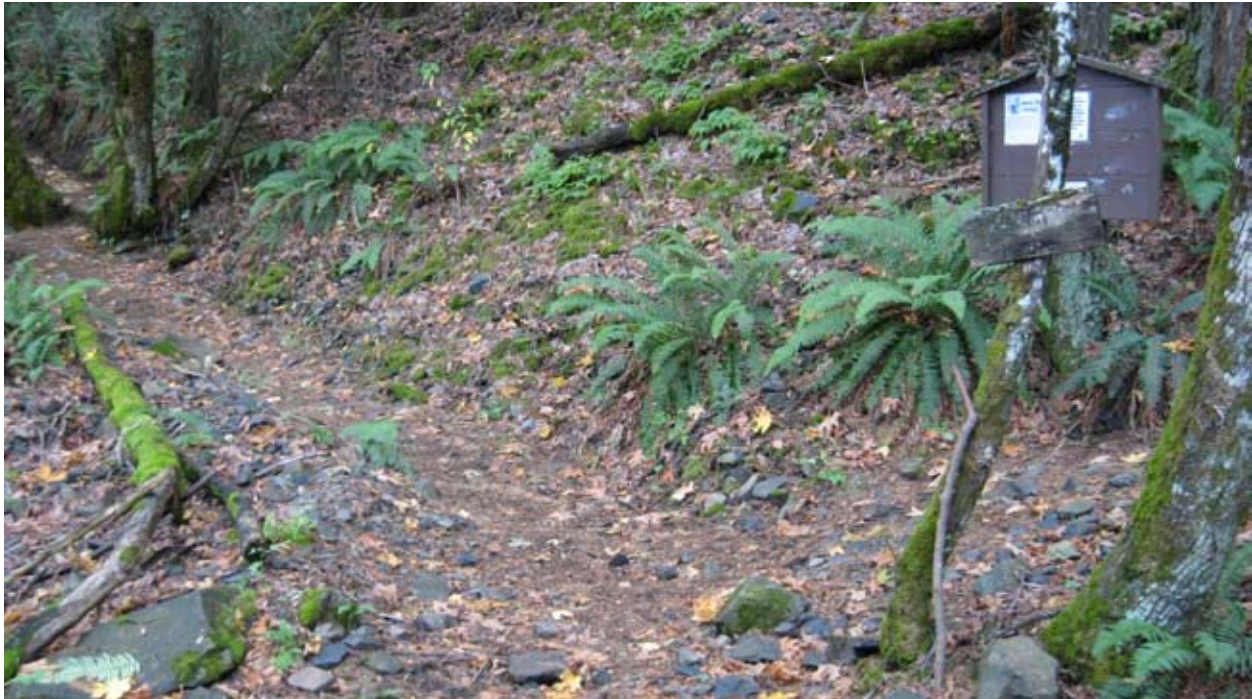
Mount Defiance Trailhead, Starvation Creek

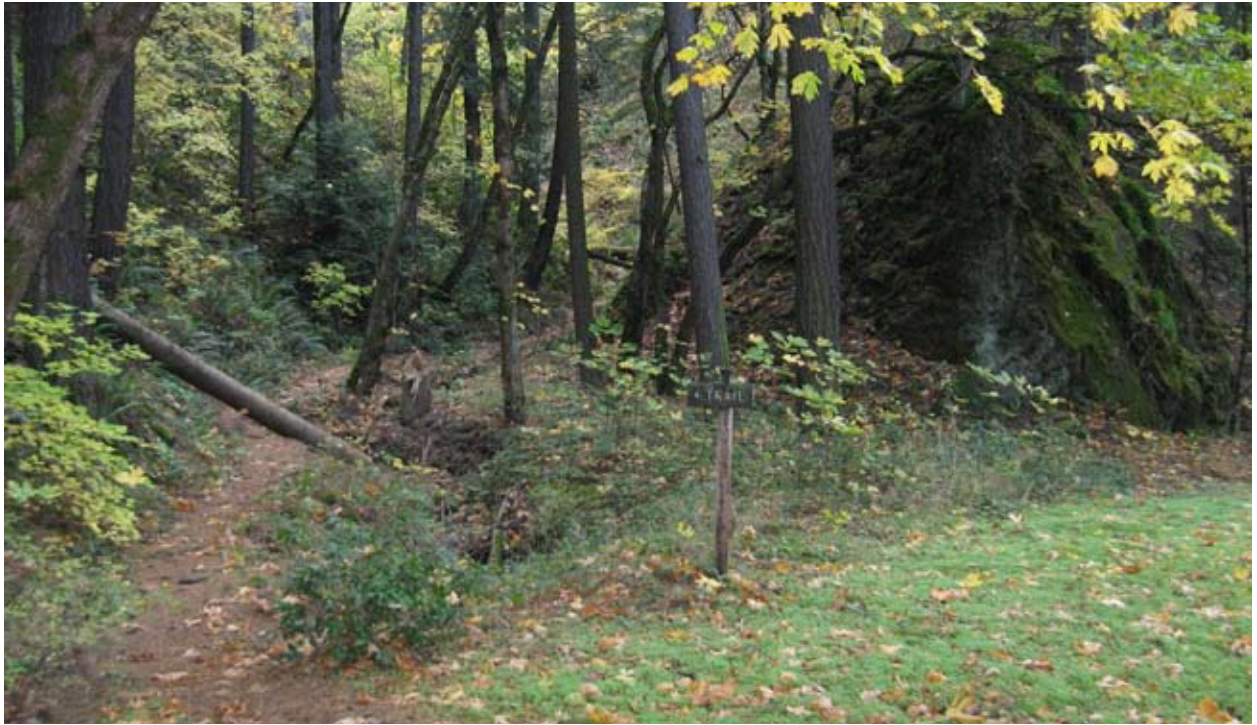
Wygant trail, Mitchell Point 2

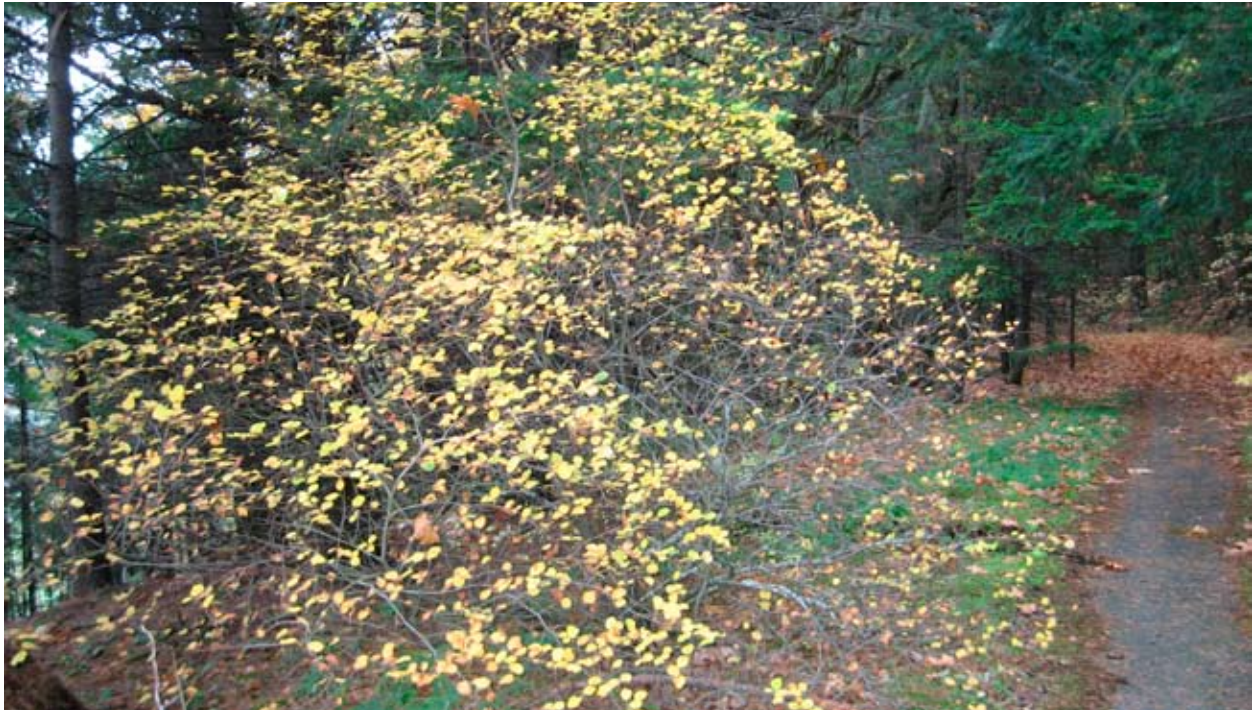
Turnout, Mitchell Point 2

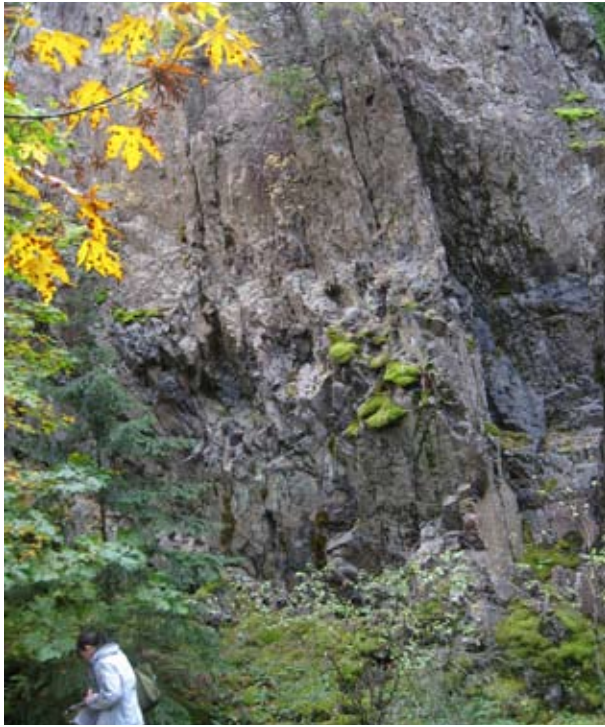
Rock outcrop, Lindsey Creek

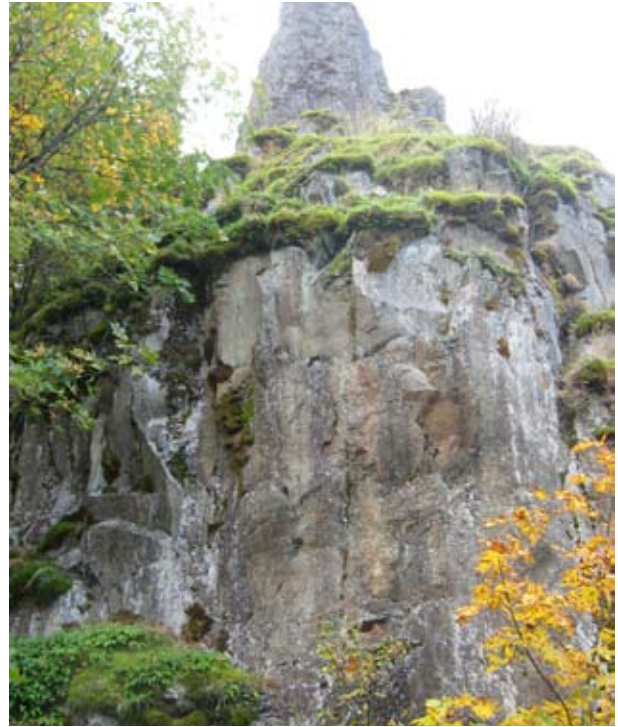
Rock cut, Lindsey Creek

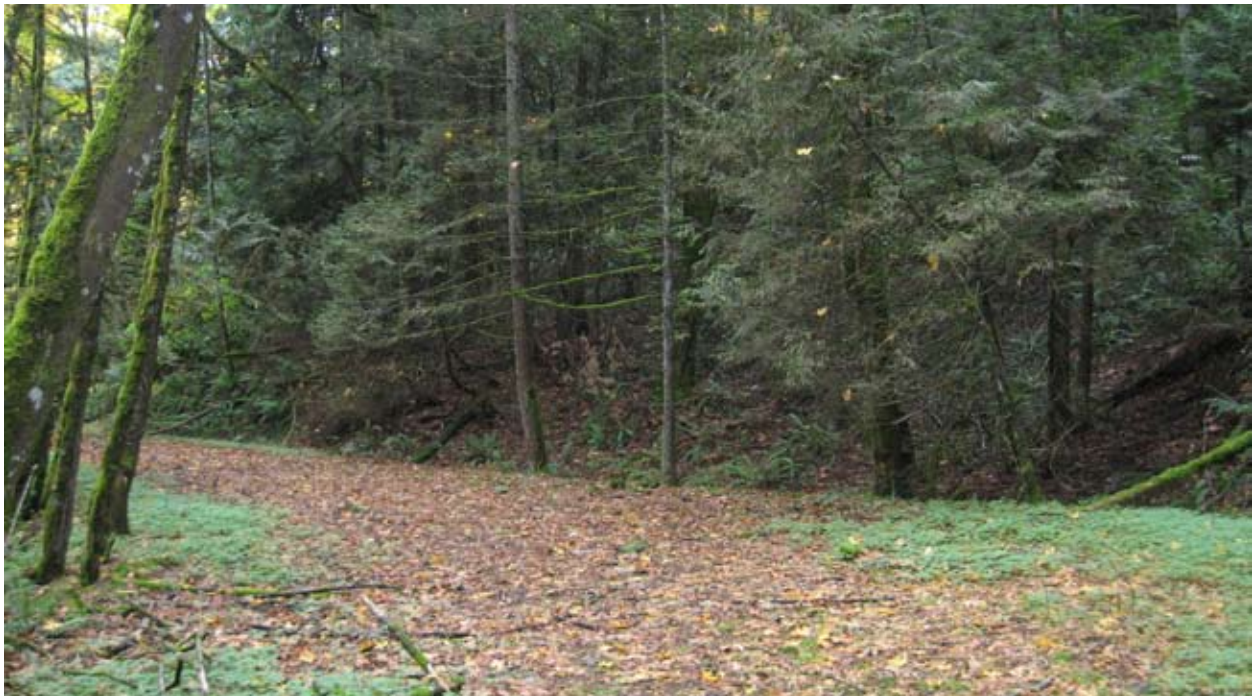
Fill through, Lindsey Creek

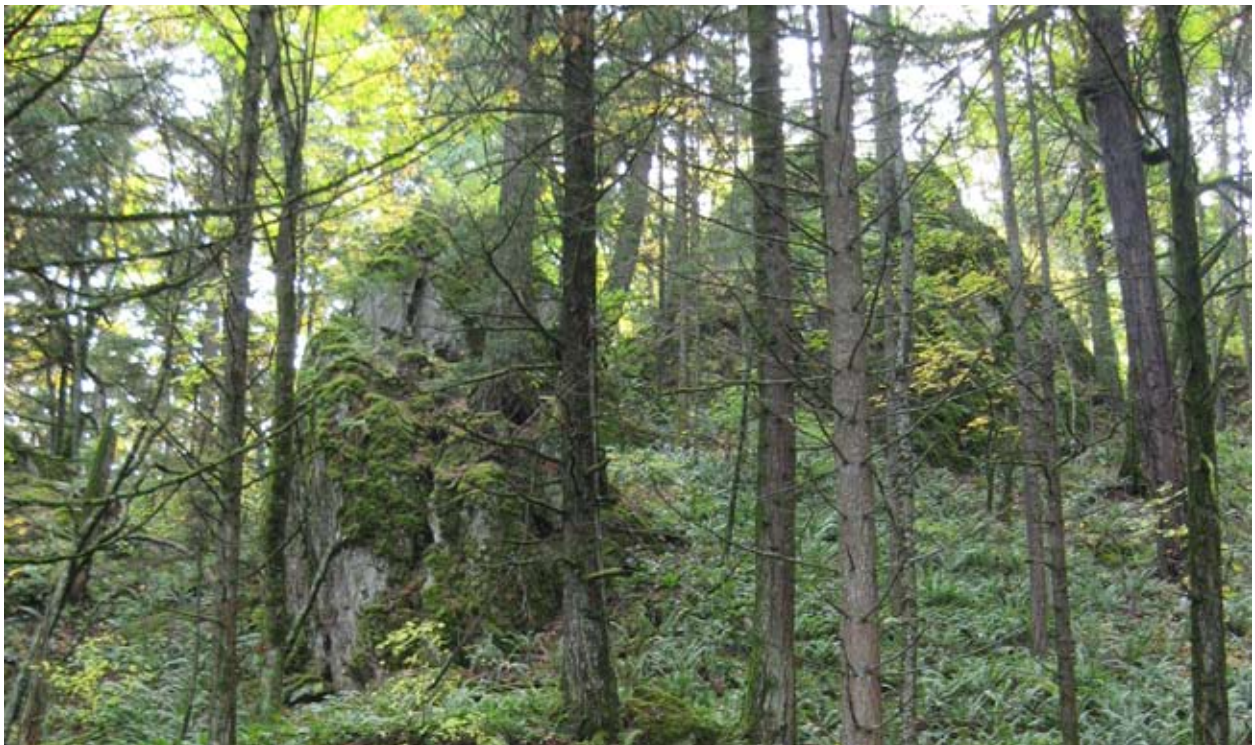
Lindsey Creek, vista up draw

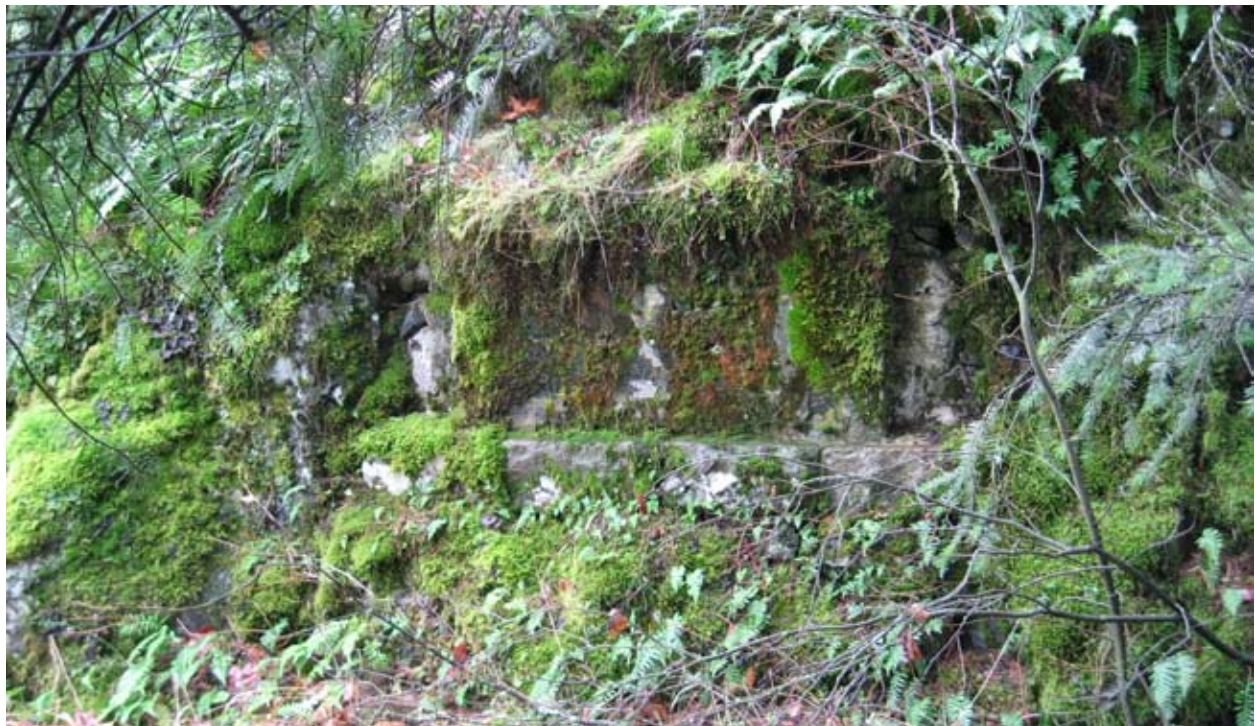
Archaeological features identified by the inventory survey include remains of concrete guard rail from the 1940s and concrete rubble by the side of the road, the original location of the plaque commemorating the “honor men” who built the road replaced by the HCRH.

Plaque site, Shellrock Mountain

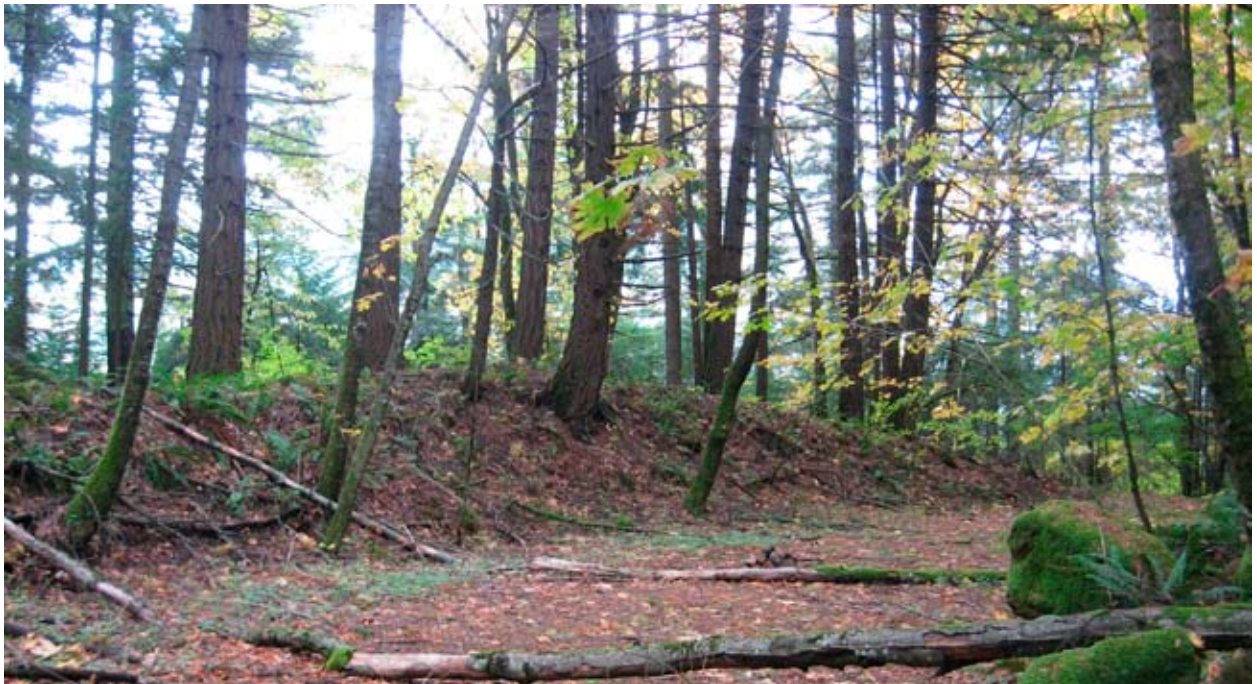
Cut through, Lindsey Creek, overgrown with trees

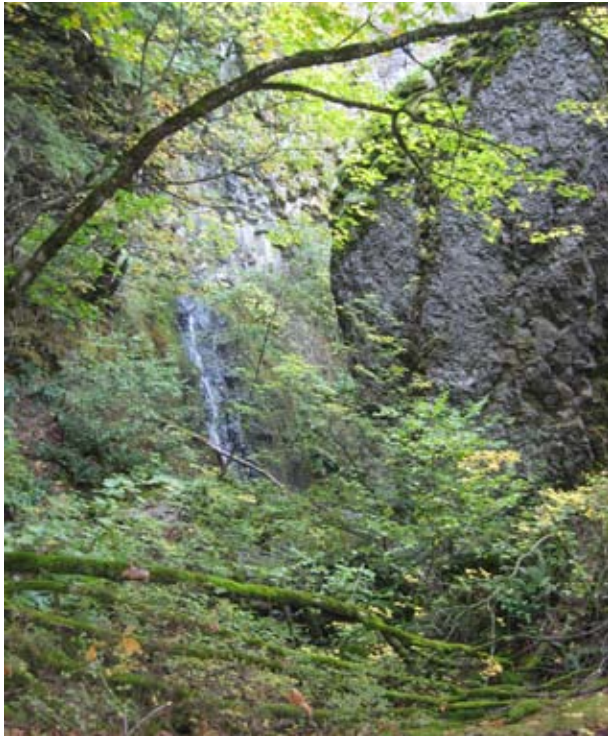
The major view in the segment is a framed vista of Cabin Creek Falls from the road. The view of the falls is framed by a towering boulder or rock outcrop. The 1939 aerial shows this area as more open than it is today; now it is overgrown with trees and vegetation. To the east of the falls is another view of rock columns, also obscured by trees.

Cabin Falls vista, Starvation Creek Segment

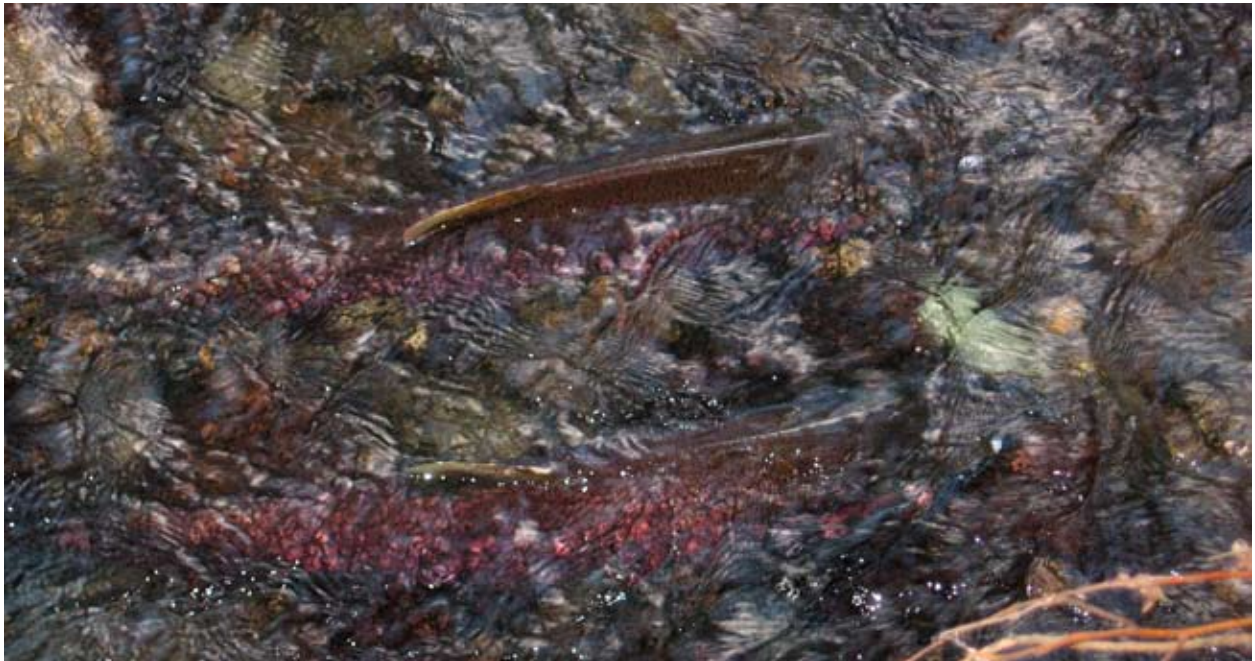
Salmon, Fall 2009, Perham Creek.

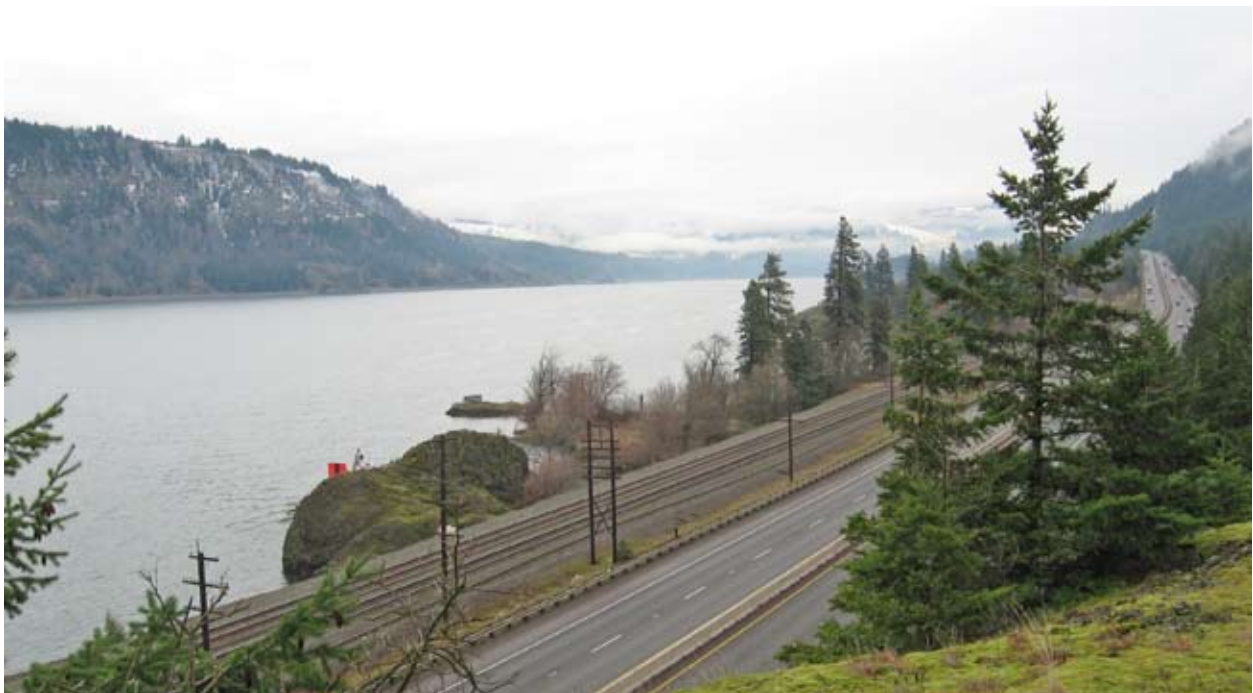
View east from west end of Mitchell Point East.

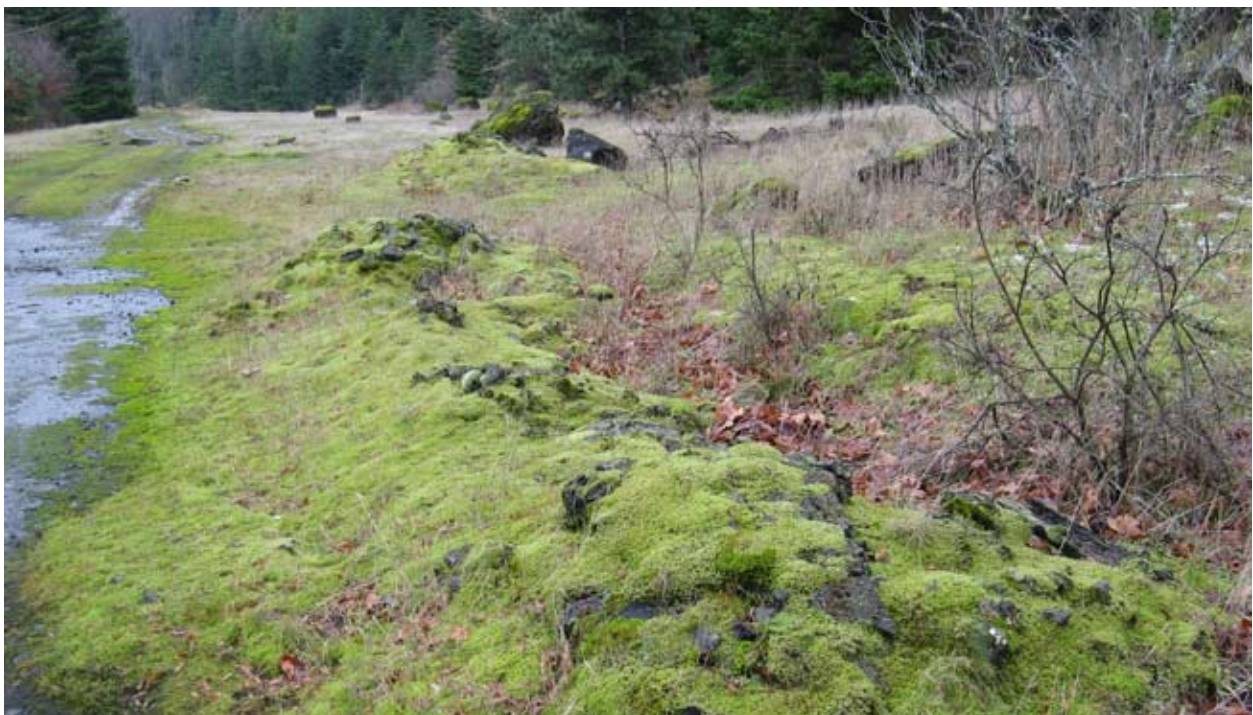
Asphalt heap, roadbed and disused quarry site, Mitchell Point East.

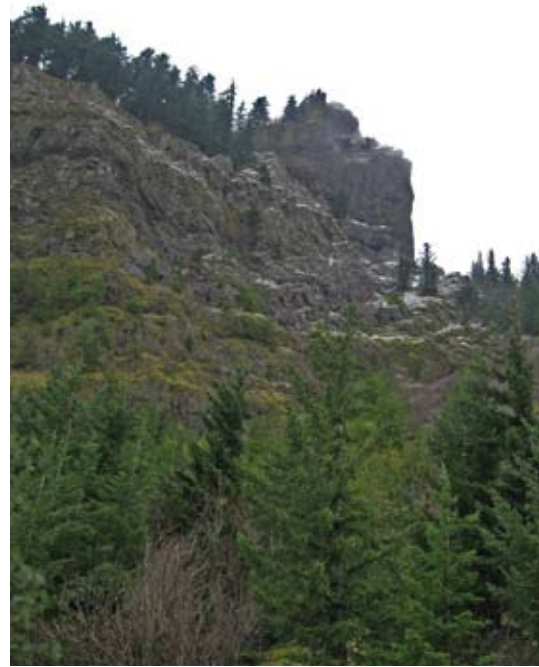
Vista of Mitchell Peak from quarry.

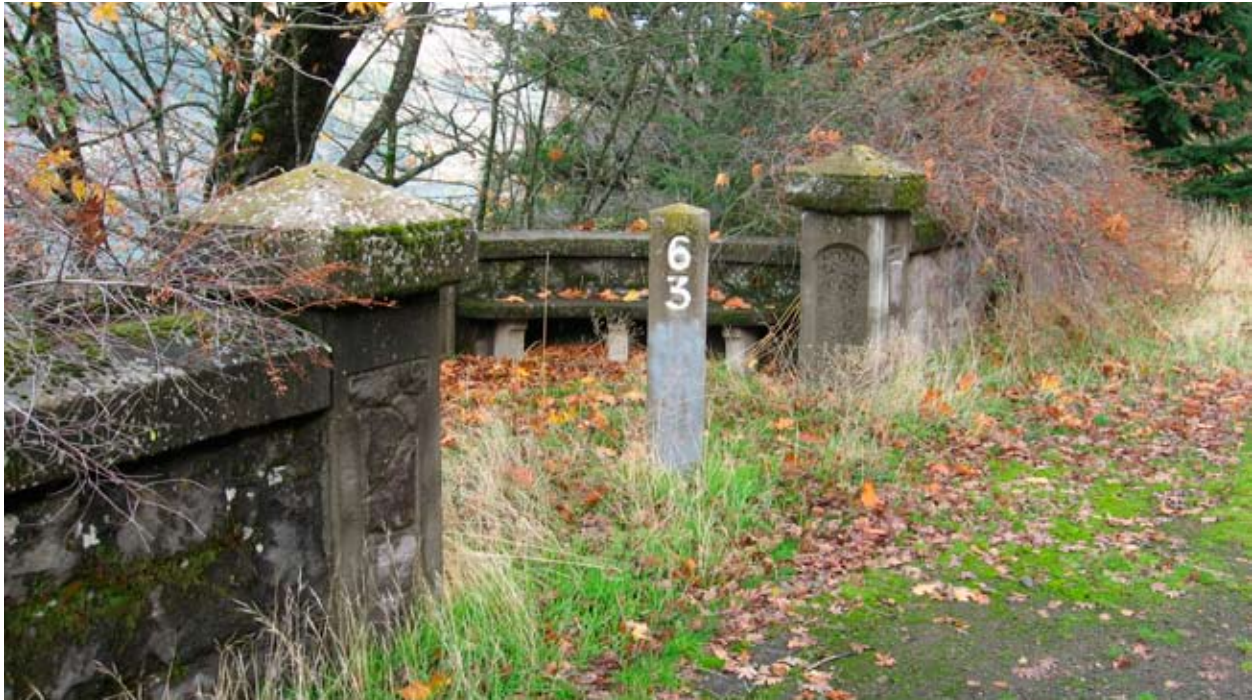
Reconstructed viewpoint, Ruthton Point

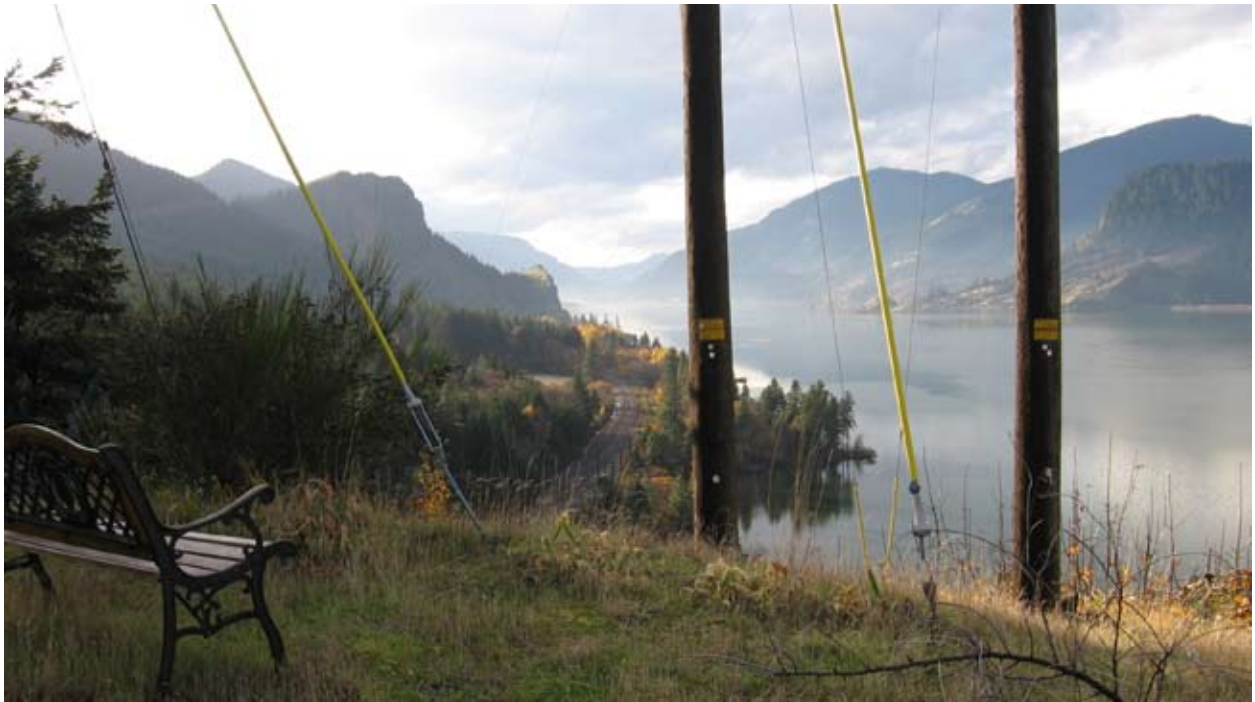
Viewpoint, with powerlines in foreground. Ruthton Point

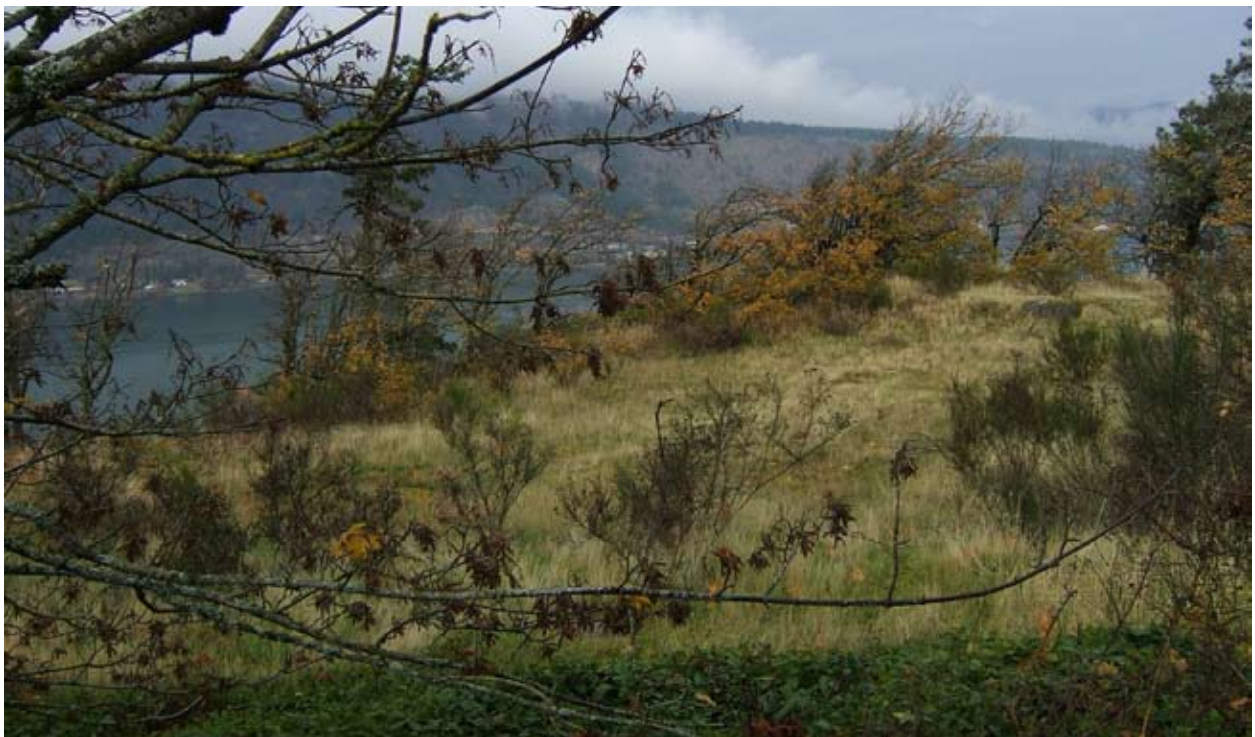
The cliff top adjacent to the Ruthton Park fragment has a rectilinear space and stone remnants that may reflect a previous development. The 1939 aerial shows a building to the east, so this may have been parking or a garden area. There is a stone structure in the drainage between Ruthton Park and the road fragment that may have been a structure associated with the highway, or with the development

Archaeology, former building site, Ruthton Park, Ruthton Segment 2

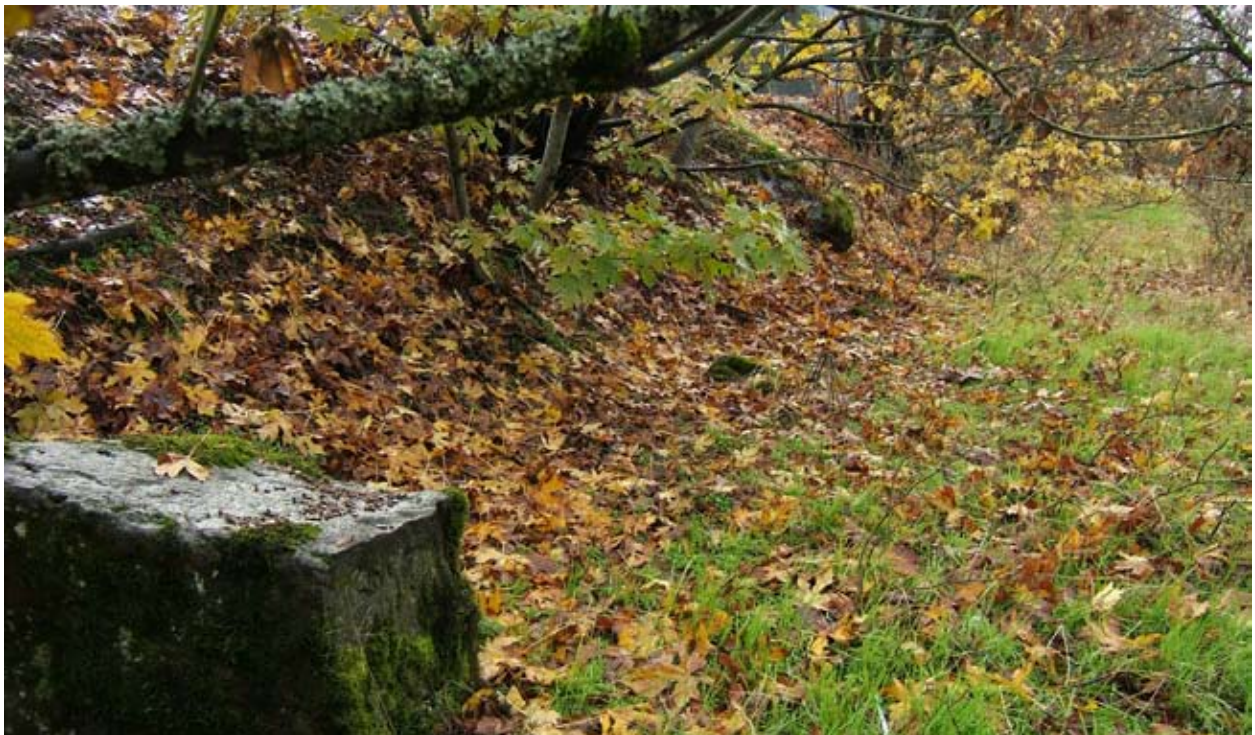
The Ruthton Park segment pavement is in poor condition. It is overgrown with moss, shrubs and trees. The edges of the roadbed are buried or have been lost to the construction of the frontage road immediately above it. This segment ends in trees and rock at just before a small seasonal drainage cuts across it, at the fenced boundary of Ruthton Park itself.

Edge stone, roadbed, Ruthton Park, Ruthton Segment 2

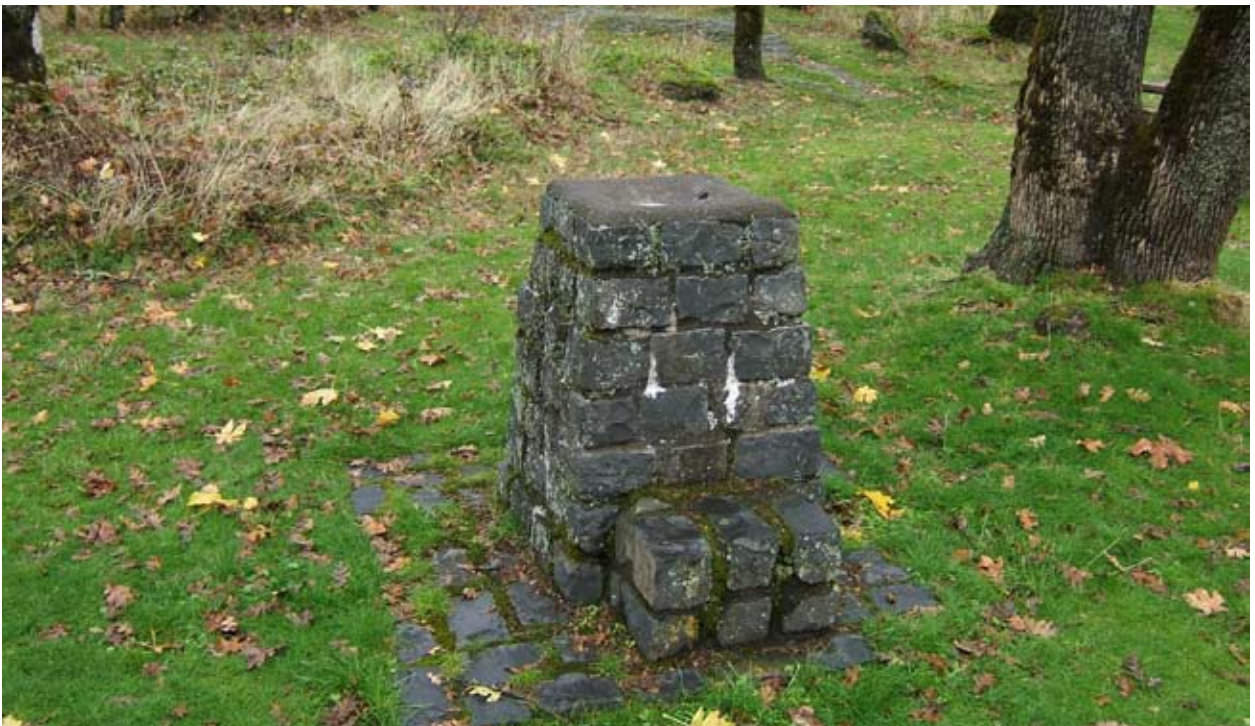
Drinking fountain, Ruthton Park

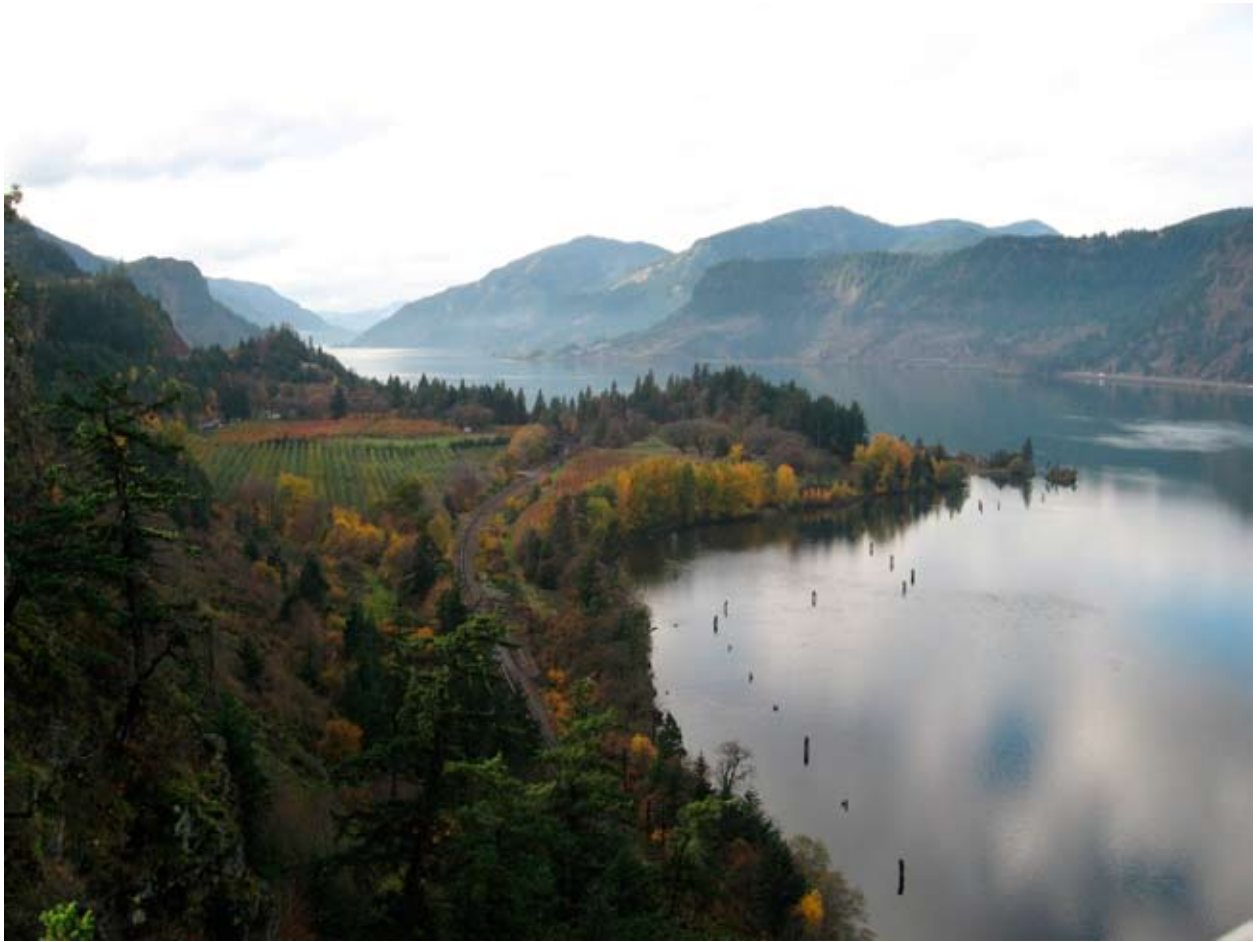
View, Ruthton Point from Ruthton Park
